## City of Alexandria, Virginia

## MEMORANDUM

SUBJECT: REPORT ON ALEXANDRIA FIRE DEPARTMENT INCIDENT ANALYSIS OF THE RESPONSE TO THE AUGUST 25, 2007, FIRE AT 6101 EDSALL ROAD (ALEXANDRIA KNOLLS WEST)

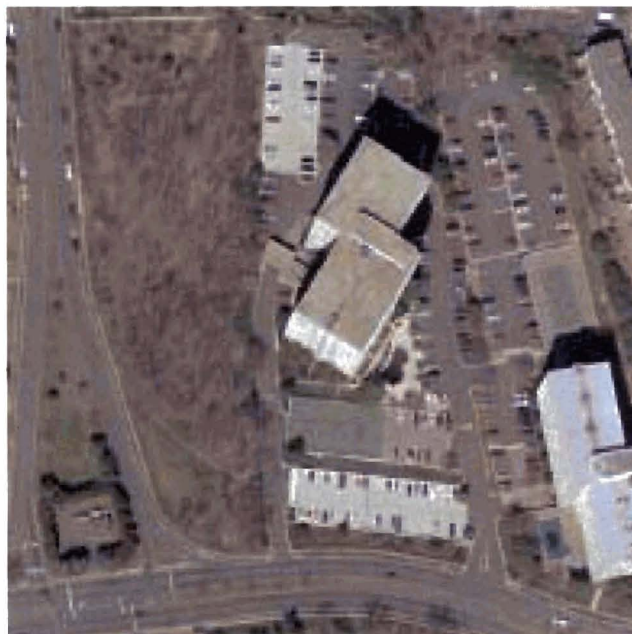
**Aerial View – 6101 Edsall Road**

The building is constructed on a slope and set back from Edsall Road in a manner that makes it difficult to view from the street. Access to the building is provided by a loop driveway that connects with the public street in two locations. The roadway provides the legally required access for fire apparatus, although the width, slope and curvature present challenges for maneuvering and positioning large apparatus.

The private access roadways allow for aerial apparatus to be positioned along the two faces of the building. Only the lower floors can be reached with aerial apparatus and the setbacks and slope of the roadways further limit the areas that can be accessed from the exterior. An aerial apparatus that is positioned for use effectively blocks the roadway, preventing access by any other vehicles.

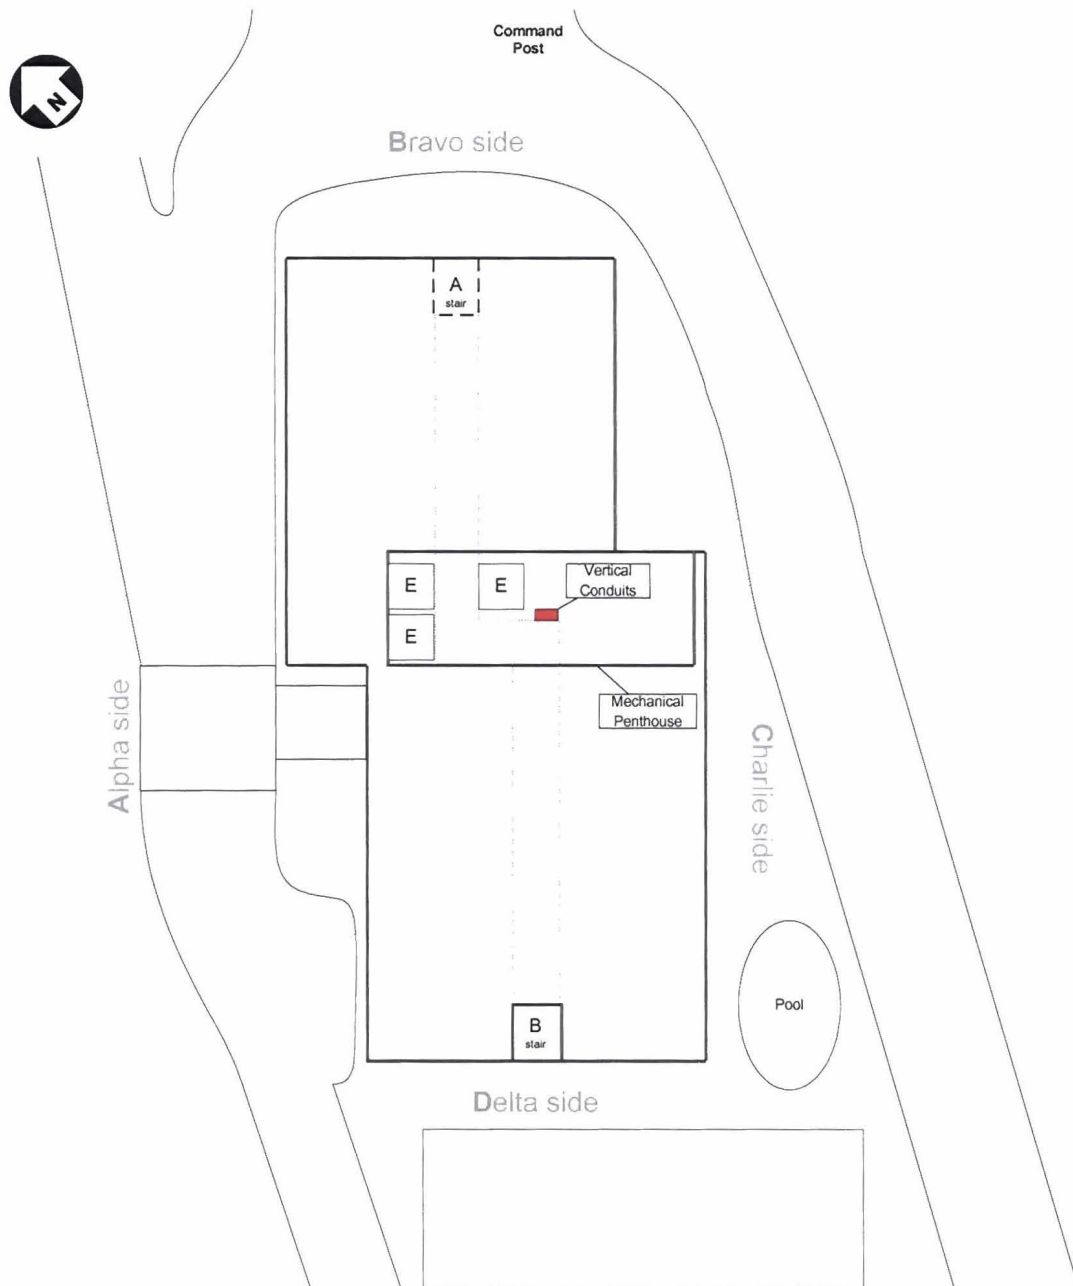
- The door that leads to the A-stairway can only be accessed by descending a set of exterior stairs from the parking lot on the Bravo side of the building.
- The door at the bottom of the B-Stairway discharges to a narrow walkway on the Delta side, between the building and the tennis courts. The walkway connects to a flight of exterior stairs on the Alpha side of the building and to the swimming pool area on the Charlie side.

- Only the B-stairway is accessible from the main lobby, via an interior corridor. The A-stairway ends one floor above the lobby and discharges directly to the exterior.

**Site and building plan, indicating elevators, stairways and corridors, and exterior access. Location of vertical conduits indicated in red.**
