Fire Station 207

DRAFT REPORT

Alexandria Fire Department - Alexandria, Virginia

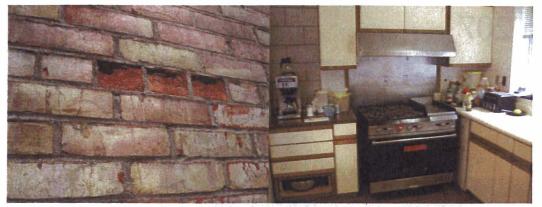
Spalling masonry

Kitchen remodel needed

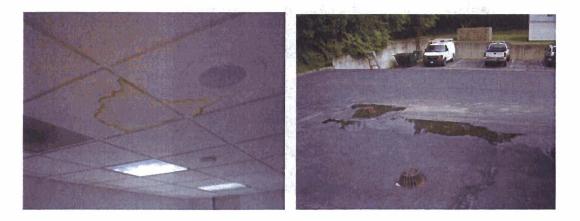
Water penetration

Roof ponding conditions

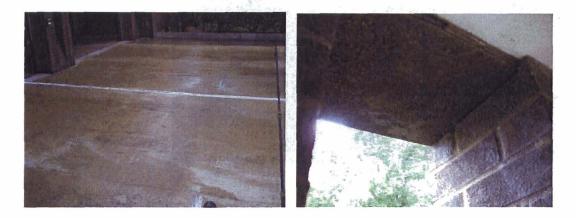
Paving issues

Exterior decay
