Docket Item # 18
BAR CASE #2009-0128

BAR Meeting
July 8, 2009

ISSUE: Alterations
APPLICANT: ASCPT
LOCATION: 528 North Washington Street
ZONE: OC/Commercial Zone

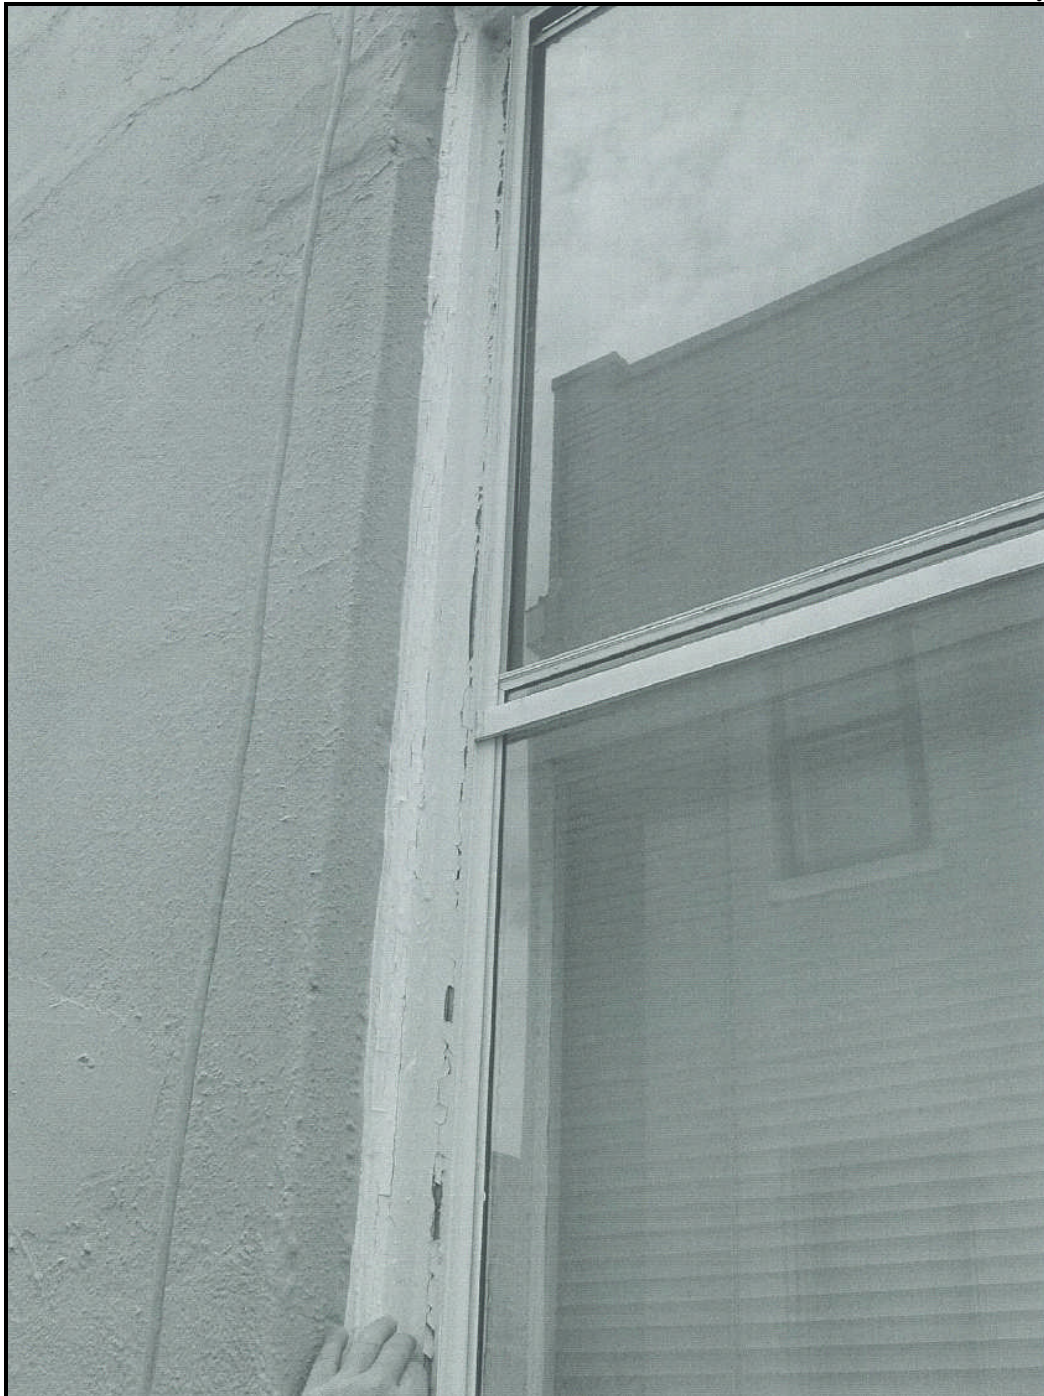
Figure 3. Window Survey: Existing Conditions-Exterior of Main Massing

Prior to filing an application, the applicant contacted BAR Staff to inquire about window replacement. Staff conducted a site visit and determined that the existing windows were not in need of replacement and advised the applicant that the existing windows should be retained and repaired, perhaps with the installation of new storm windows. Staff advised that any window replacement would require approval by the Board but noted that Staff would be unable to support wholesale replacement. Staff notes that all of the historic windows on are in good condition and are in need of only standard repair and maintenance, including sash cord replacement and re-attachment to the

weights, repair of some broken glass, sanding and painting, weather stripping, and possible metal jamb liner installation if desired. These repair items are considered standard for historic, wood window maintenance and repair.

In reviewing the application, Staff finds no convincing reason why the original windows cannot be retained and repaired. For energy efficiency, Staff recommends the applicant consider new wood, storm windows. There are many styles and materials of storm windows from which to choose, including storms that can be fitted on the interior of the window. Many studies have shown that a wood window in good condition fitted with a storm window can be as energy efficient as the more expensive replacement window. For the most energy efficient storm window option, due to the thermal exchange properties of wood, traditional wood-framed storm windows are recommended as they transfer less heat than metal-framed storms. Metal-framed exterior storm windows are currently installed on the building.

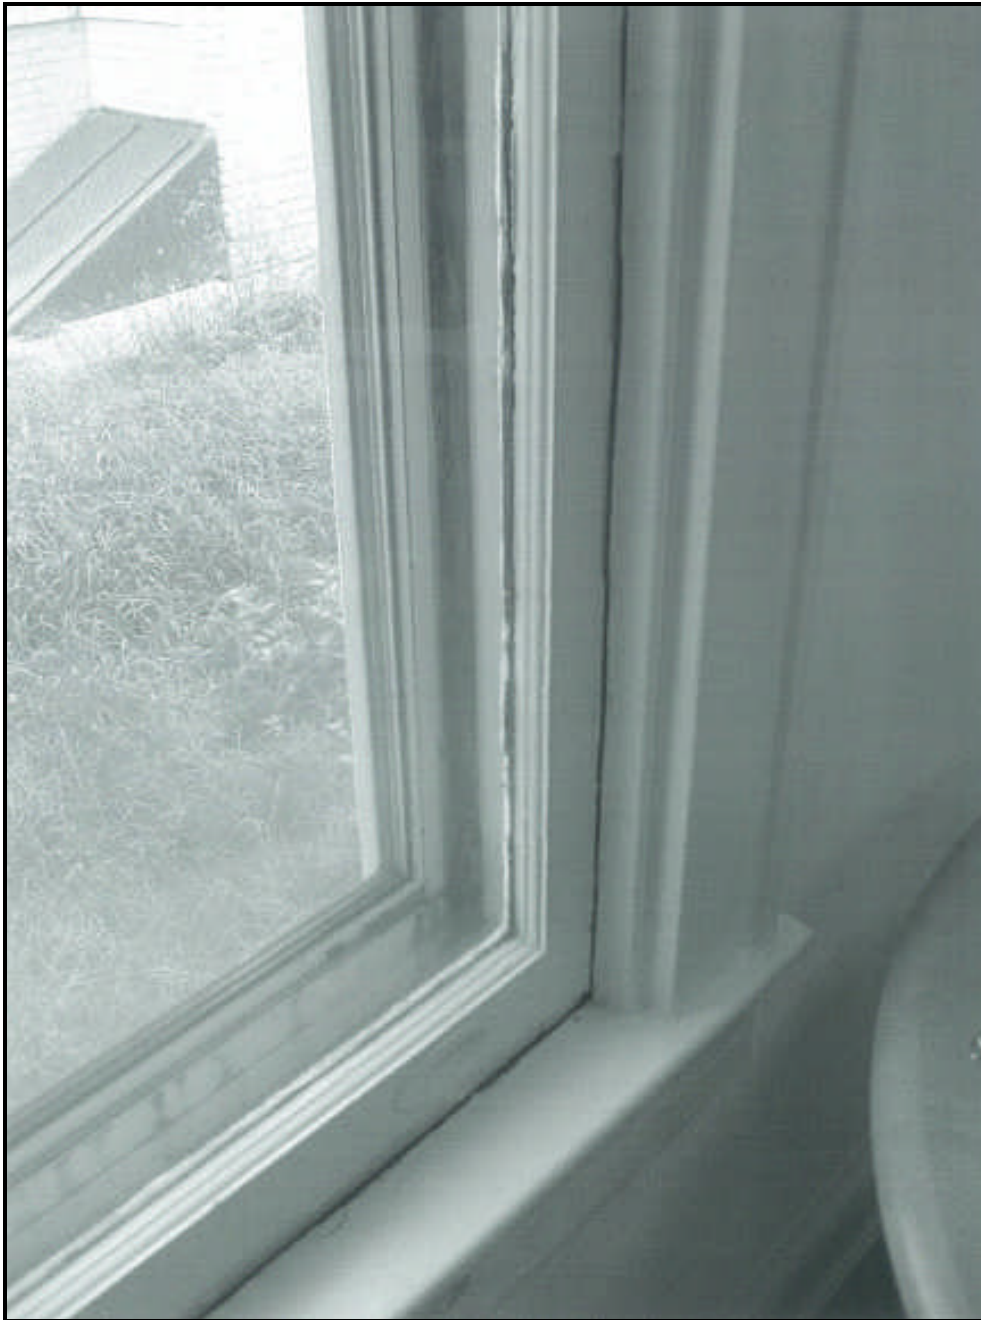
Figure 7. Window Survey: Existing Conditions-Interior of Frame Addition

It has been determined that the rear frame addition's windows are not-historic (c1970), therefore Staff does not object to their replacement.

1. That the wood, windows on the main, brick and stucco massing will be retained and rehabilitated.
2. That the wood, windows on the rear frame, second story-addition, may be replaced with one-over-one wood double-glazed windows.
