Docket Item # 5
BAR CASE # 2008-0229

BAR Meeting
January 7, 2009

ISSUE: Alterations
APPLICANT: Susan Kerr, Owner
LOCATION: 610 S. Pitt Street
ZONE: RM / Residential Townhouse Zone

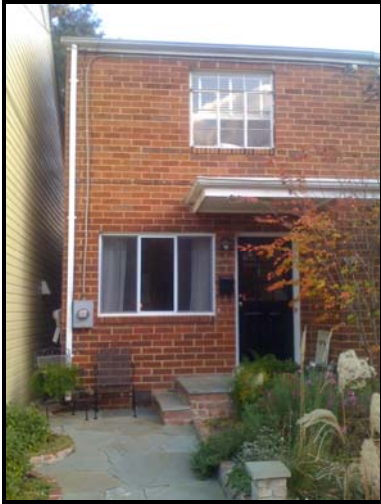
Prior to the beginning of this window replacement project, this building's front façade contained two, original, single-pane, metal, divided-light casement windows, which were installed during the construction of the townhouse (c.1950-60). The front façade currently contains one of the proposed replacement windows on the first level and an original metal casement window on the second.

Figure 1: Front Elevation (Proposed Slider on First Floor, Existing Metal Window on Second Floor)

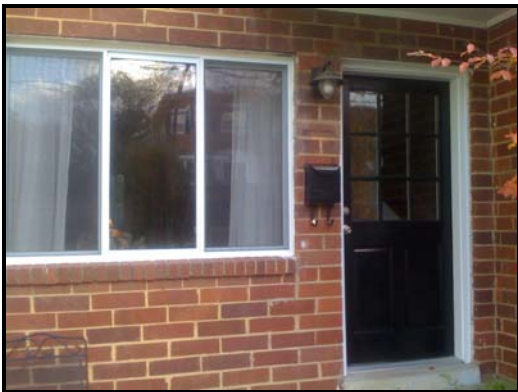
Figure 2: Proposed Slider Window

S-1 Substitute metal or wood casements with true-divided lights to replace vinyl sliders.

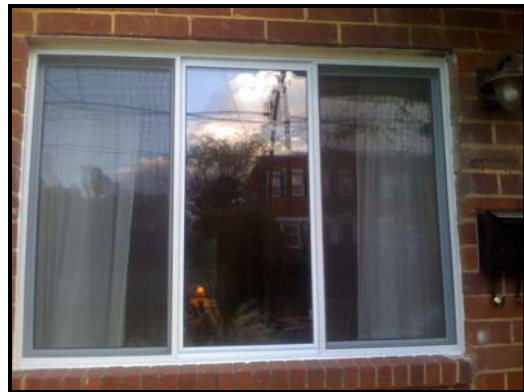
Figure 3: Proposed Slider Window

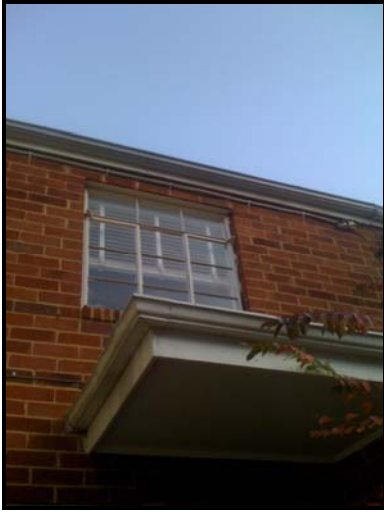
The *Design Guidelines* for the Old and Historic District “discourages plastic, vinyl and metal windows”, while “single horizontal muntin metal windows and metal casement windows are only appropriate for buildings dating from the late 1940s and early 1950s’. In this case, single-pane, metal windows are no-longer fabricated in this exact form or configuration. Upon research, metal double-pane, casement windows may be special-ordered to match the original window’s divided-light pattern. As such, a determination needs to be made whether the replacement windows for this dwelling requires the replication of the divided-light metal window in a double-pane glass form, or is the proposed sliding-sash vinyl window appropriate for this application. It has been the policy of the Board that vinyl windows are inappropriate in any form in the historic district. As such it is recommended that these windows should be replaced with windows appropriate to the period and style of the building.

Figure 4: Existing Metal Single Pane Window

1. Rehabilitate the existing metal, single-pane windows on the front elevation of the house and, if desired, work with BAR staff to design appropriate storm windows for weather efficiency; or,
2. Remove the existing windows on the front elevation of the house and replace them with solid metal double-pane casement/fixed sash windows, fabricated to replicate the divided-light pattern and sash composition of the existing windows. These new windows may have an applied color or a natural metal finish.
