Docket Item # 10  
BAR CASE #2009-0107

BAR Meeting  
June 17, 2009

**ISSUE:** Alterations  
**APPLICANT:** Deborah Dittmann  
**LOCATION:** 425 North Columbus Street  
**ZONE:** RM/Townhouse zone

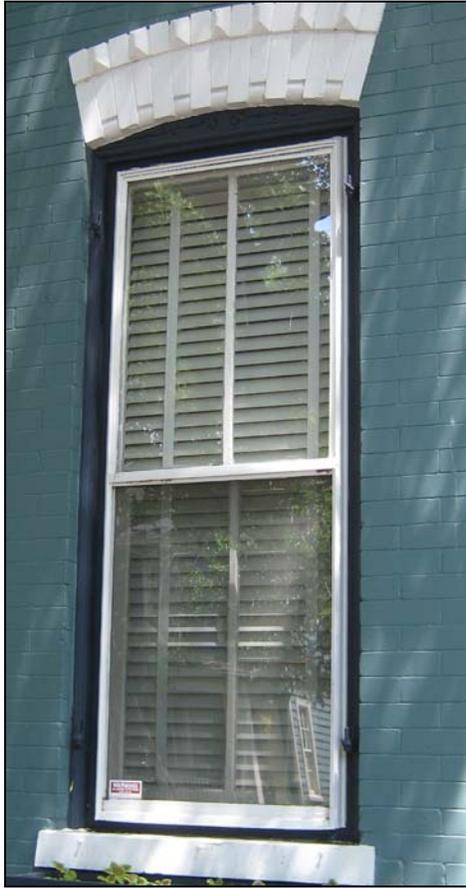
The applicant has noted that the windows on her house have slightly different muntin widths. During a site visit, Staff confirmed that the windows on the second story have a slightly wider and flatter muntin than on the first story. However, the neighboring property at 423 North Columbus Street also has this same configuration, suggesting it was part of the original design. Further, it is not uncommon for historic windows to have slightly different muntin profiles depending on their location, as evidenced across the street at 426 North Columbus.

**Figure 3. Original window, first story, front elevation.**

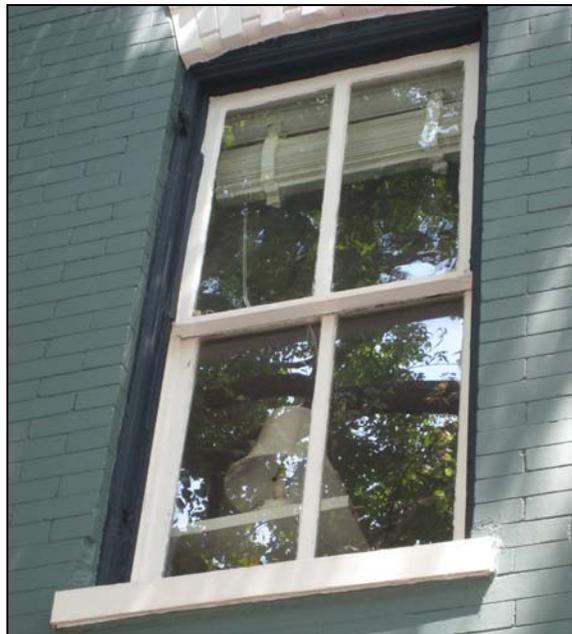
**Figure 4. Original window, second story, front elevation.**

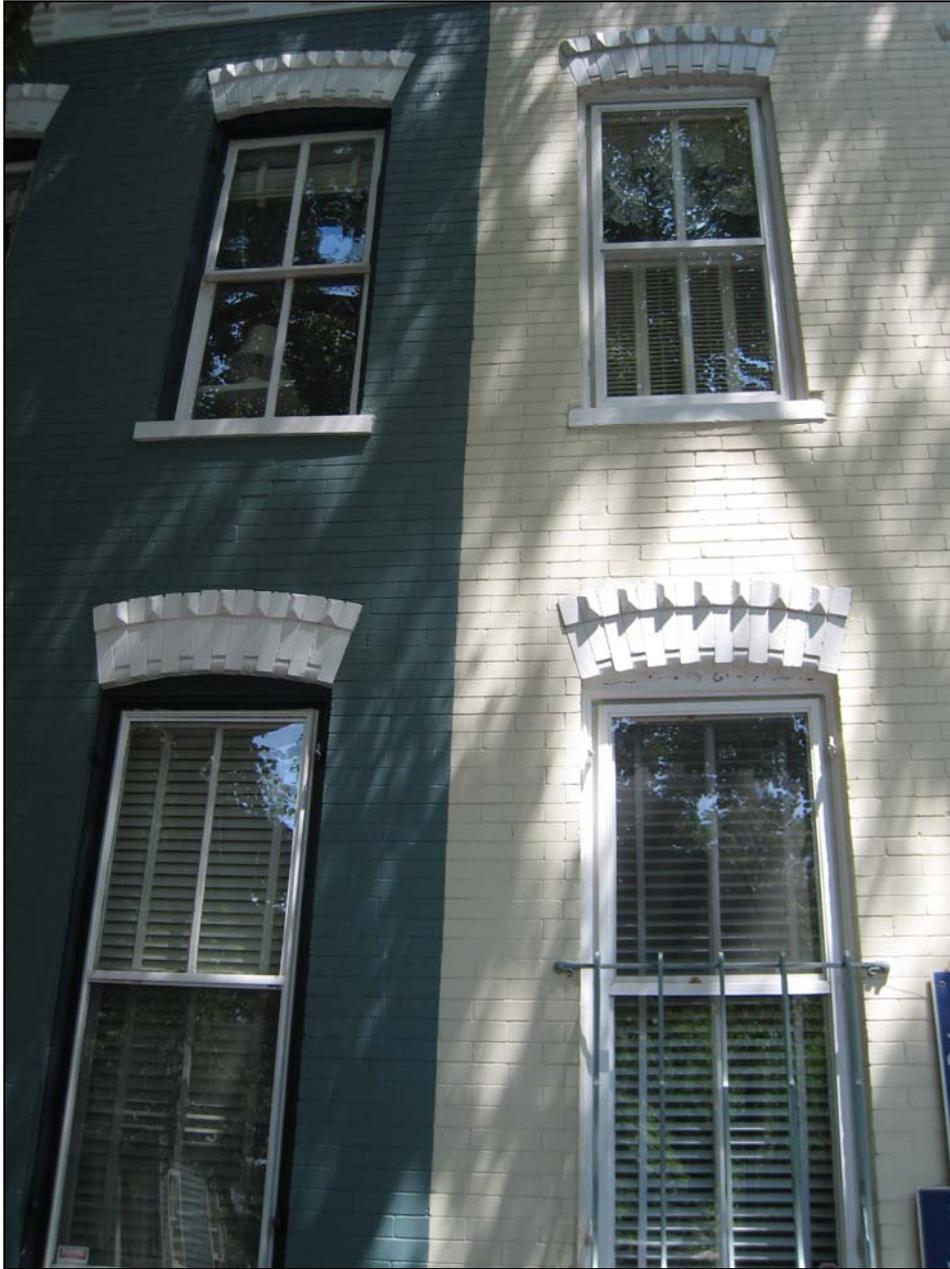
Prior to filing an application, the applicant contacted BAR Staff to inquire about window replacement. Staff conducted a site visit and determined that the existing windows were not in need of replacement and advised the applicant that the existing windows should be retained and repaired, perhaps with the installation of new storm windows. Staff advised that any window replacement would require approval by the Board but noted that Staff would be unable to support wholesale replacement. Staff notes that all of the windows on the front elevation are in good condition.

replacement windows only be approved when the existing historic windows are beyond repair, which is not the case at 425 North Columbus Street. Furthermore, research with historic maps indicates that this dwelling was constructed as one of a pair of townhouses. The other half of the pair is located at 423 North Columbus Street and also retains its original windows, indicating that the windows proposed for replacement date from approximately 1890.

Figure 5. Front elevation showing original windows at 425 and 423 North Columbus Street.

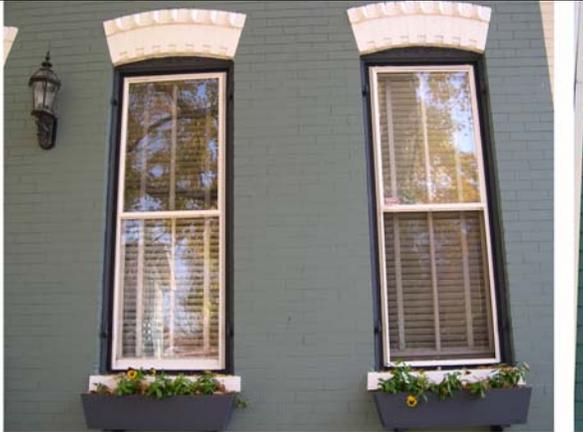
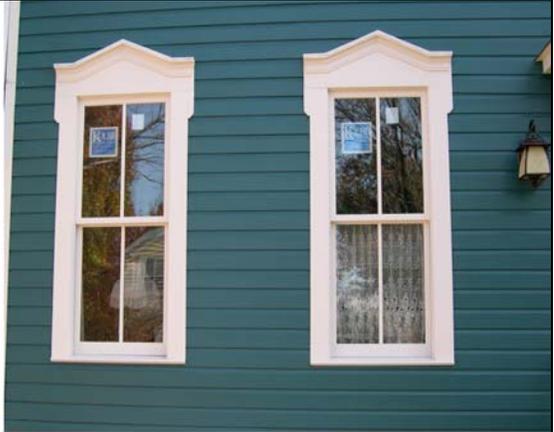
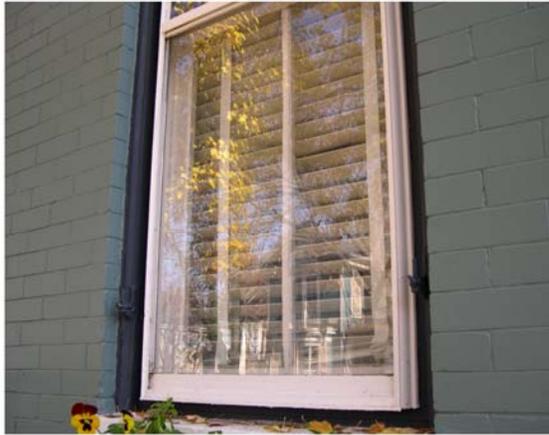
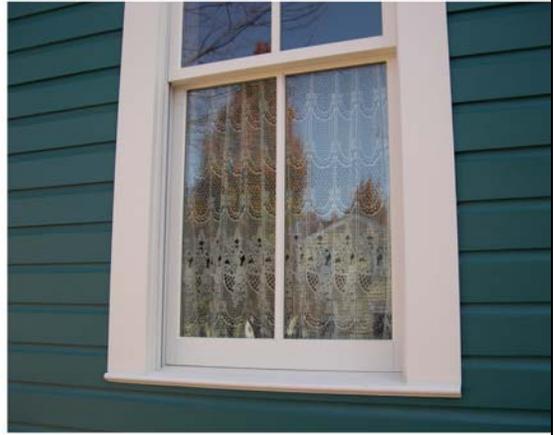
The applicant has also noted that replacement windows, similar to what is proposed, were administratively approved last year at 435 North Columbus Street. While that dwelling is of a similar period and architectural style to 425 North Columbus, Staff notes that each case must be reviewed on its own merits. In the case of 435 North Columbus, Staff was able to administratively approve replacement windows because the existing windows were themselves replacement windows and were not considered historically appropriate (six-over-one windows). The replacement windows in this instance were true divided light, double-glazed wood windows.

**Figure 6. Original windows at 425 North Columbus St. and replacement windows at 435 North Columbus St.**

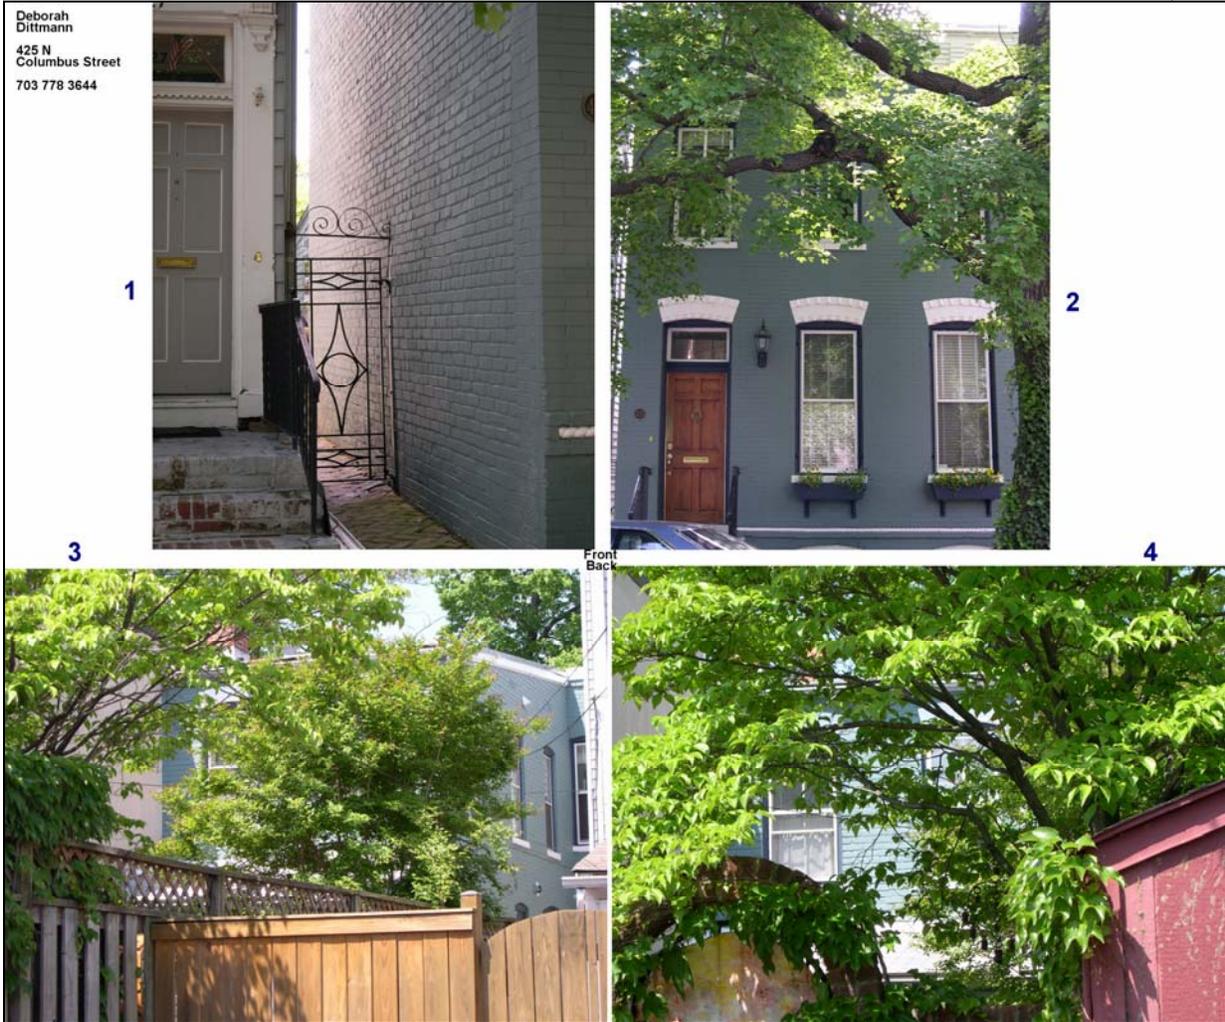
Figure 7. Additional views of side and rear elevations. Bottom pictures taken from public alley.

Staff finds that the current submission request is not consistent with *Design Guidelines*. Should the applicant find the need to replace individual windows which are beyond repair on the side and rear elevations, Staff can administratively approve single or double glazed, true divided light wood windows for those windows.
