Docket Item # 9  
BAR CASE #2009-0295

BAR Meeting  
January 6, 2010

**ISSUE:** Alterations  
**APPLICANT:** Duncan Blair for Patrick Street Associates, LLC  
**LOCATION:** 211 North Patrick Street  
**ZONE:** RB/Residential

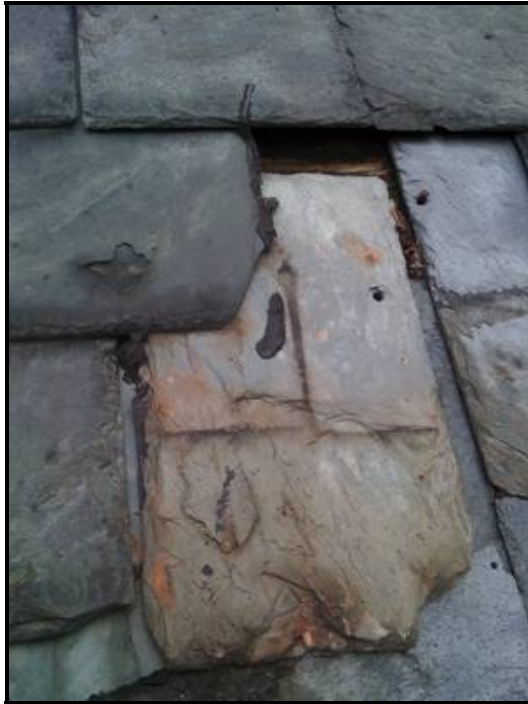
Staff believes that the applicant has demonstrated that the existing slate shingles are beyond repair, and that a new roof is necessary. The average live span of a slate roof is generally 60 to 125 years. Staff believes that the slate roof at 211 North Patrick Street is likely original to the construction of the house, making it approximately 120 years old. The applicant has provided a number of photographs which show significant damage due to cracking and spalling. The National Park Service’s Preservation Brief 29, *The Repair, Replacement & Maintenance of*

*Historic Slate Roofs*, strongly encourages the retention of historic slate and repairing where needed. The NPS brief states that: "If 20% or more of the slates on a roof or roof slope are broken, cracked, missing, or sliding out of position, it is usually less expensive to replace the roof than execute individual repairs." The percentage of damage to individual slates appears to exceed 20% at 211 North Patrick Street.

**Figure 11: Photo of damaged slate.**

- S- 1 Repair/replace deteriorated slate roof with authentic slate of similar dimensions and color.

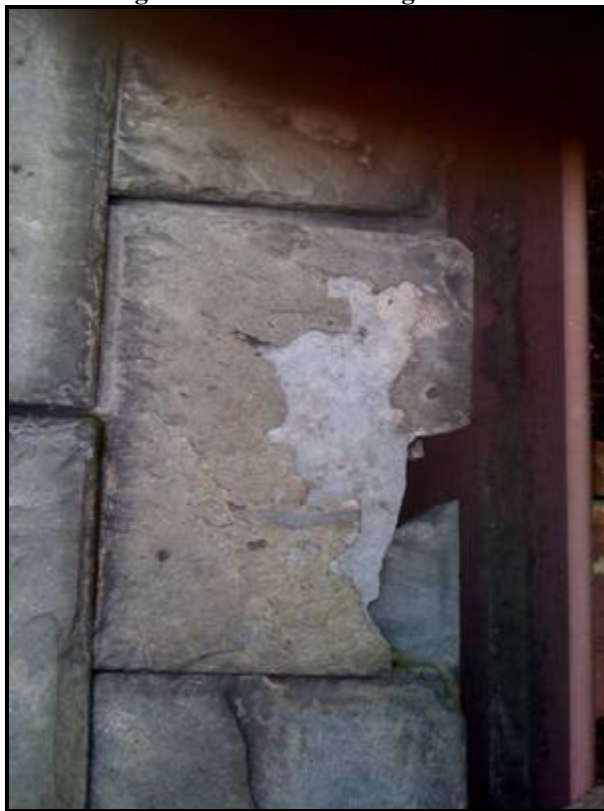
**Figure 12: Photo of damaged slate.**

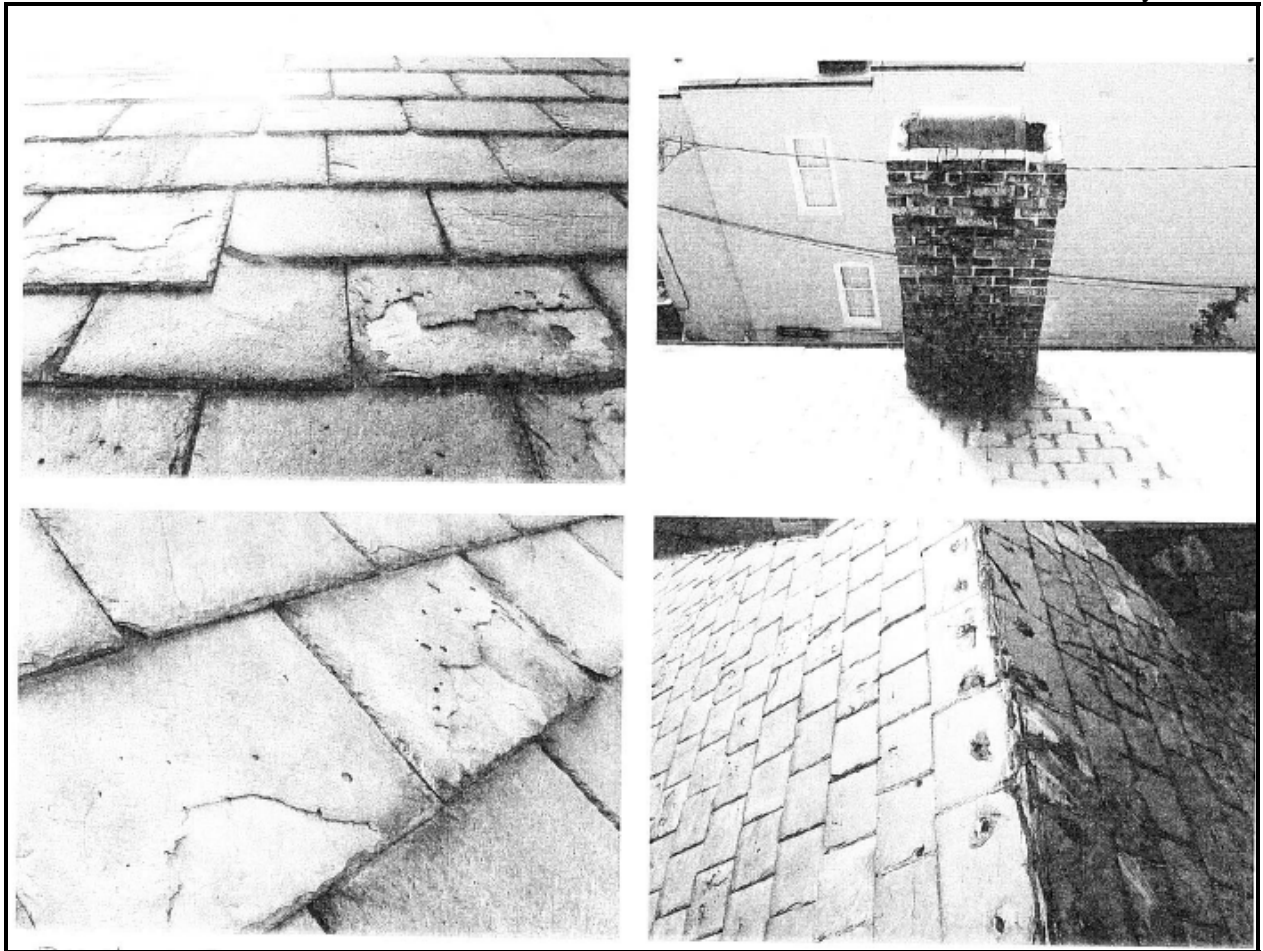
**Figure 13: Photos of roof with damaged slate.**

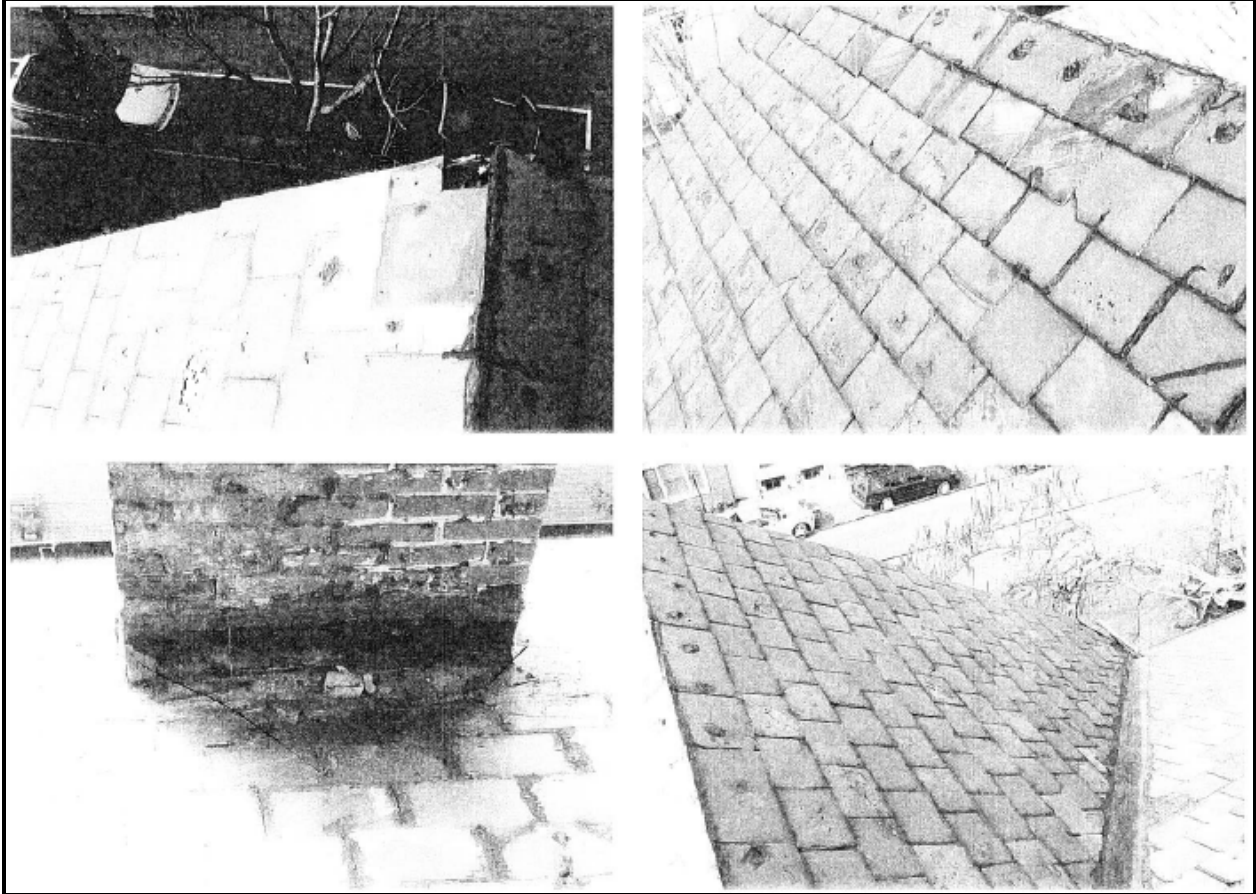
**Figure 14: Photos of roof with damaged slate.**

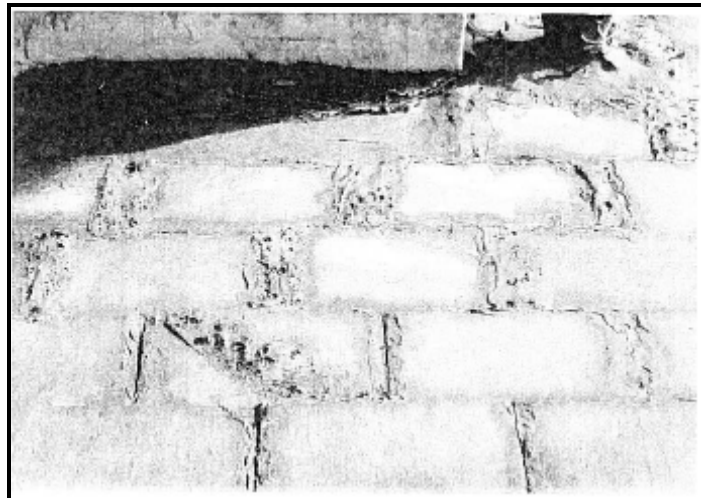
**Figure 15: Photo of damaged slate.**
