Docket Item # 4 BAR CASE # 2011-0040

BAR Meeting March 16, 2011

ZONE:	RM/Residential
LOCATION:	317 South Saint Asaph Street
APPLICANT:	Richard and Margaret Moose
ISSUE:	Alterations (Porch Floor Replacement)

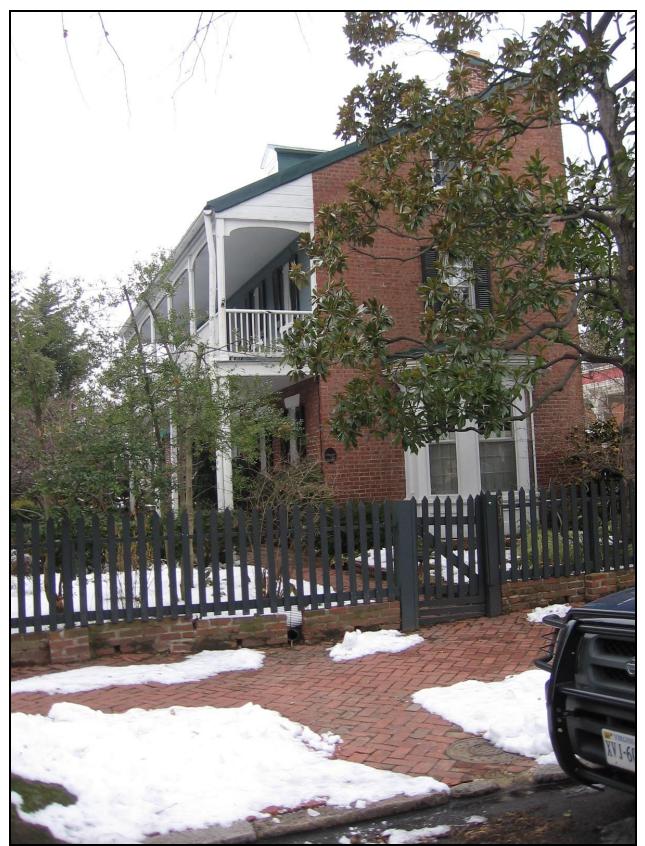
The porch floor is minimally visible from St. Asaph Street.

Figure 1. Photo of porch from St. Asaph Street.

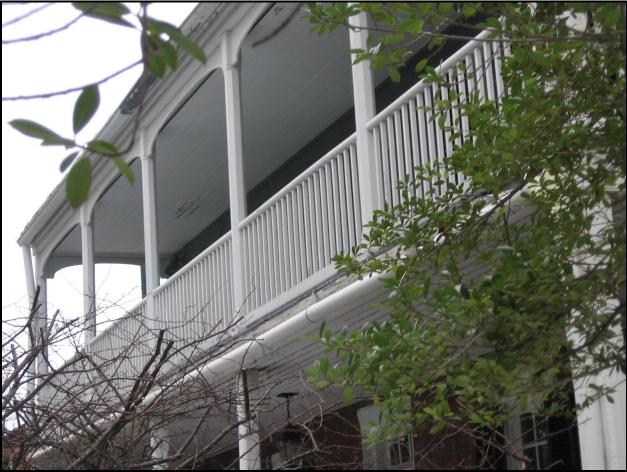
Figure 2. Photo of porch.

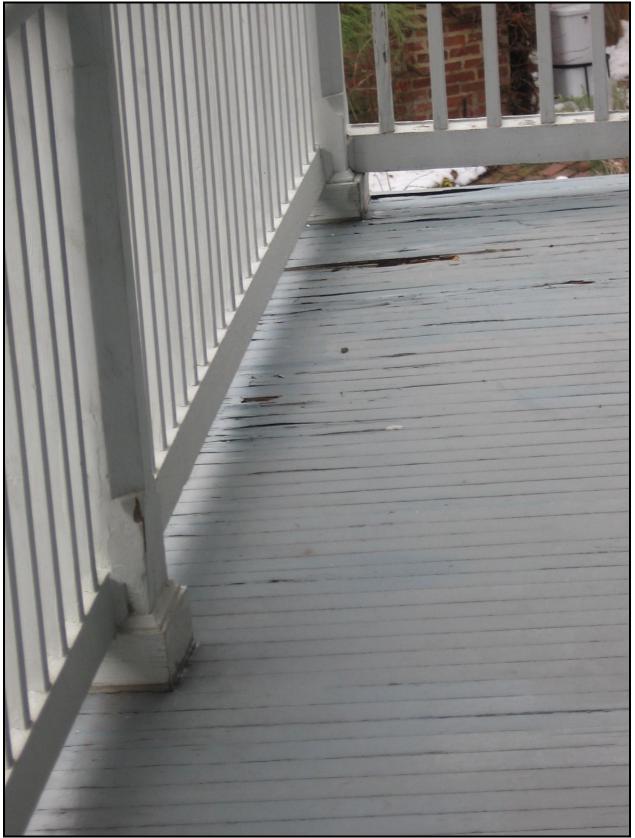
The applicant is requesting approval of a new porch floor at 317 South Saint Asaph Street. The second story porch floor is in poor condition and the applicant wishes to replace with it with PVC composite (Azek brand) porch boards. The applicant states that a synthetic floor material will last longer than a traditional wood floor.

Figure 3. Photo of porch floor damage.

Given the age of the porch, Staff can only support the installation of a wood, tongue-and-groove porch floor. AZEK's own website notes that this solid PVC trim product has only been commercially available since the mid-1980s. Fortunately, there are a number of relatively new natural wood flooring products which may help the applicant achieve a floor with a longer life span than with the traditional southern white pine porch flooring commonly used. Certain species of wood are much more resistant to rot than pine, including: Ipe, which is a sustainably harvested wood from the rain forests of Brazil which has natural waterproofing properties. Mahogany and Cedar are some other wood options. There are also some relatively new 100% treated wood products on the market – this is wood which has been thermally treated or impregnated with a solvent to make it rot resistant. As part of the recent investigation of appropriate Modern and Sustainable Materials, Staff attended an industry presentation at Smoot Lumber, one of Alexandria's oldest businesses. Smoot carries some treated wood products, manufactured by companies such as Design Pine, Pure Wood, Nature Wood, and EcoVantage. Smoot represented that these products are economically competitive with PVC composite flooring.

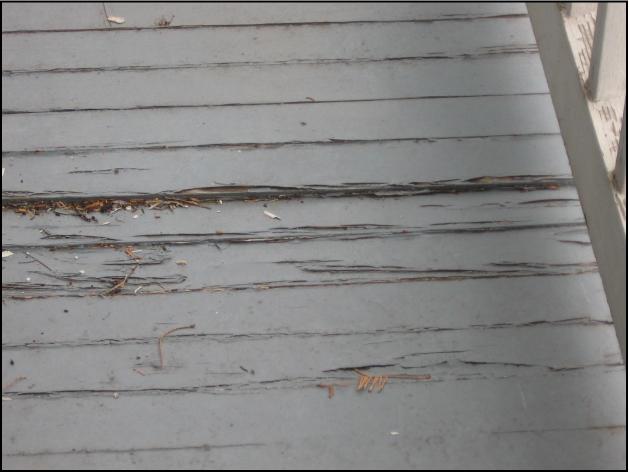
Figure 4. Photo of porch floor damage.
