Docket Item #6  
BAR CASE # 2011-0179

**ISSUE:** Alterations (Window and Door Replacement)

**LOCATION:** 516 North Columbus Street

**BAR CASE #2011-0179**

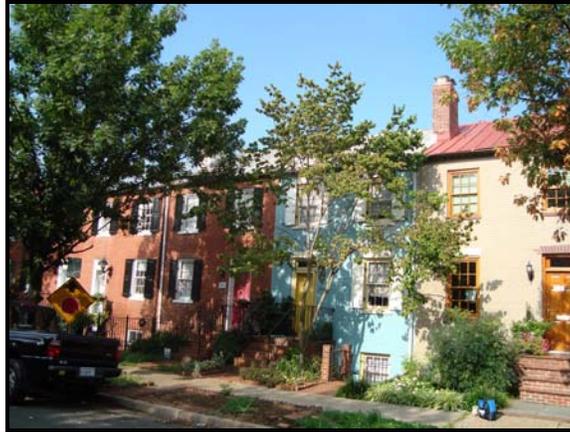
Since the existing windows and doors have been removed and disposed, the BAR is left only with historic documentation and architectural clues to provide information on what materials would have been original to the building. Sanborn Insurance maps illustrate that the eight townhouses in this row (506-520) were all constructed during the same time. Additionally, a site visit has revealed that these townhouses were built as four mirror image pairs (see image below.)

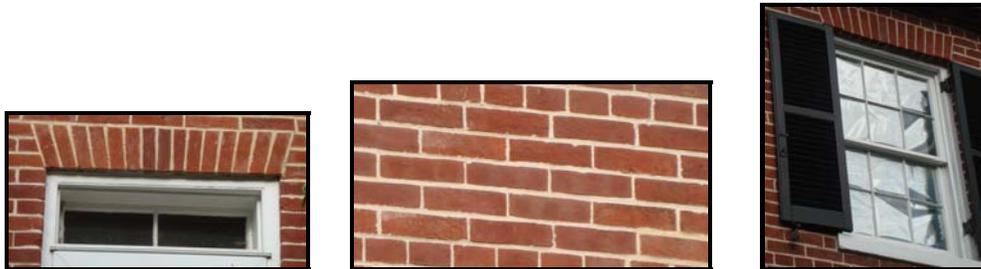
An examination of these buildings revealed that the original front elevation features were likely 6/6, 5/8" muntin, single-glazed wood windows with operable shutters, six-panel wood doors, two--light transoms, brick jack arches, and denticulated brick cornices (as shown below). These vernacular Colonial Revival features are atypical for the late Victorian-era but, as Staff and the BAR are discovering, groups of these remarkably accurate Federal Revival style buildings were constructed in the late 19<sup>th</sup> or early 20<sup>th</sup> century in several pockets throughout Old Town with both 2/2 and 6/6 windows.

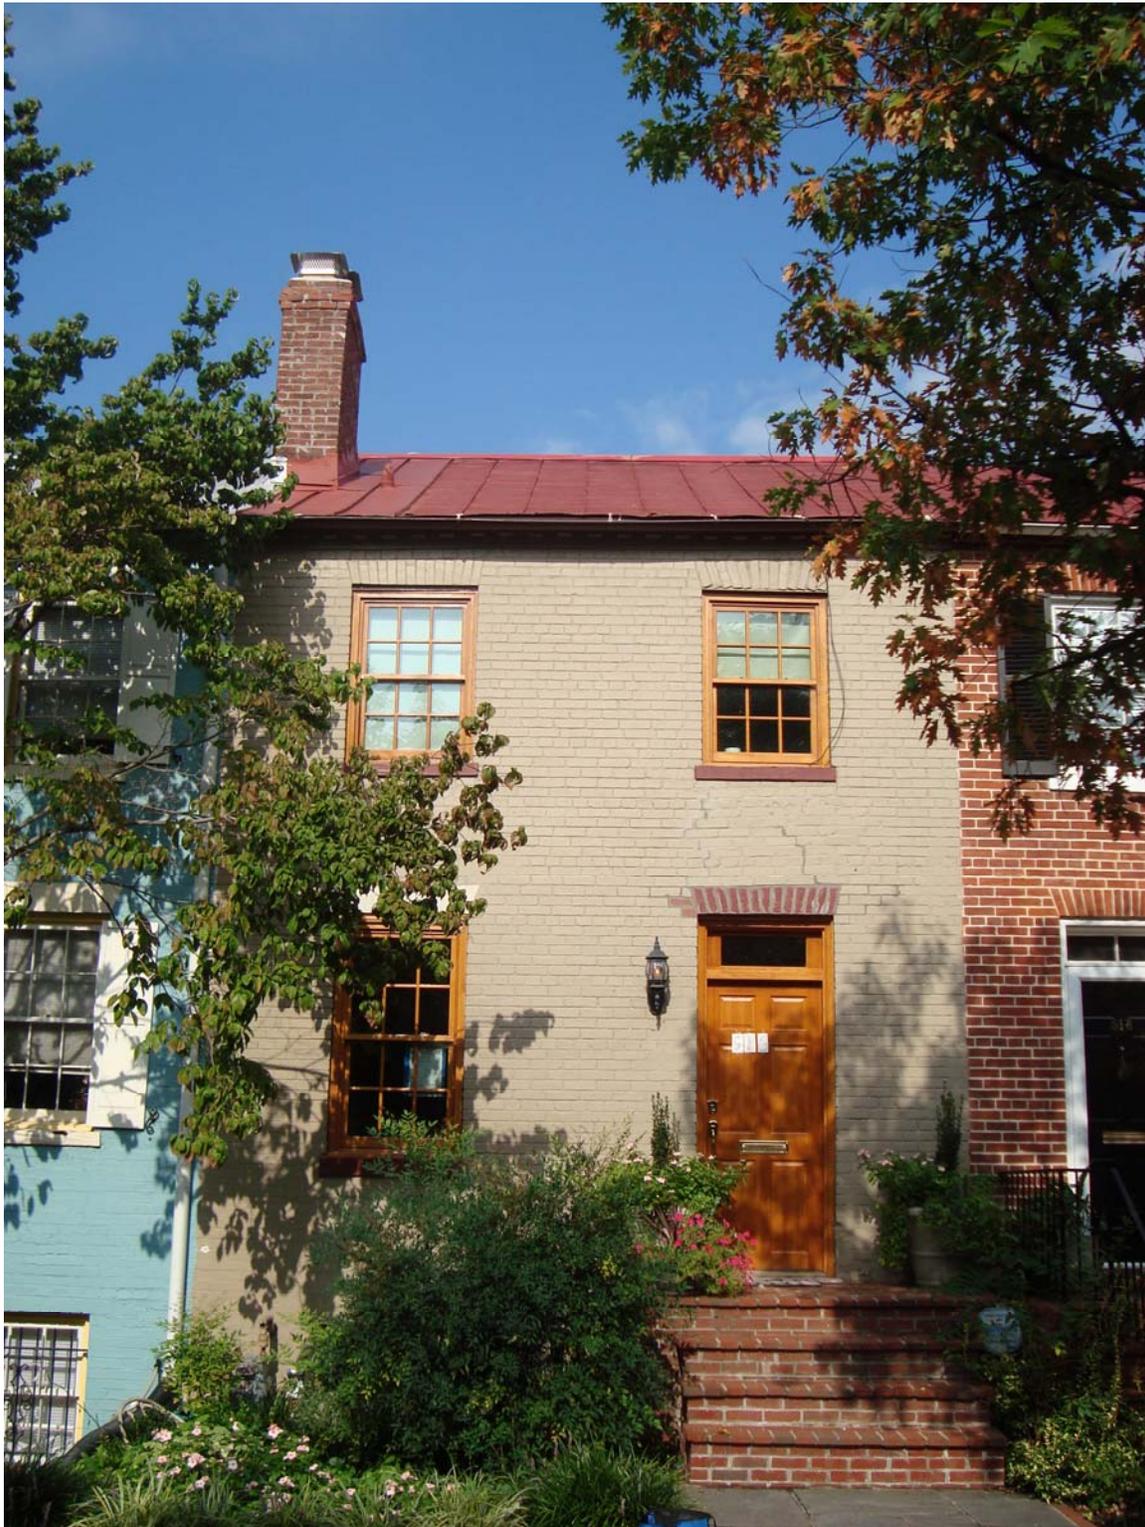
Figure 1. Proposed Door and Window Replacement

The proposed Jeld-Wen windows are high quality and meet the *Alexandria Replacement Window Performance Specifications* in the Board's *Window Policy* with three exceptions. First, the proposed transom is not a historically appropriate design. Based on what appears to be the original transom on several adjacent dwellings, a two-light configuration would have been the original light pattern. Second, the stiles on each side of the transom sash are very wide and do not match the original, or any transom sash that Staff is aware of. The Alexandria Performance Specifications require that the "dimensions and proportions of the window rails, stiles, muntins, frames sill and exterior trim must match historically appropriate window proportions." Staff recommends that the Board require that the transom be replaced with one with more historically accurate proportions.

However, several issues complicate this particular case. Both Boards have approved double-glazed windows on several other buildings on this block<sup>1</sup>, though this was prior to recent adoption of the window policy. Fortunately, the buildings are set back from the sidewalk and separated by a small, landscaped front yard, so visibility of the insulated glass thickness is limited from the public way. In addition, whether 2/2 or 6/6 windows were original to these eight buildings, they all have 6/6 windows now and installation of 2/2 windows on this one dwelling would be visually odd in this context. Staff, therefore, reluctantly recommends approval of the existing simulated divided-light 6/6 windows in this location.

Staff recommends approval of the Certificate of Appropriateness, as amended, for the existing front door and windows but with replacement of the transom in a more historically appropriate design.
