Docket Item # 4
BAR CASE # 2011-0351

BAR Meeting
January 4, 2012

ISSUE: Partial Demolition (west parapet wall)

LOCATION: 304 Duke Street

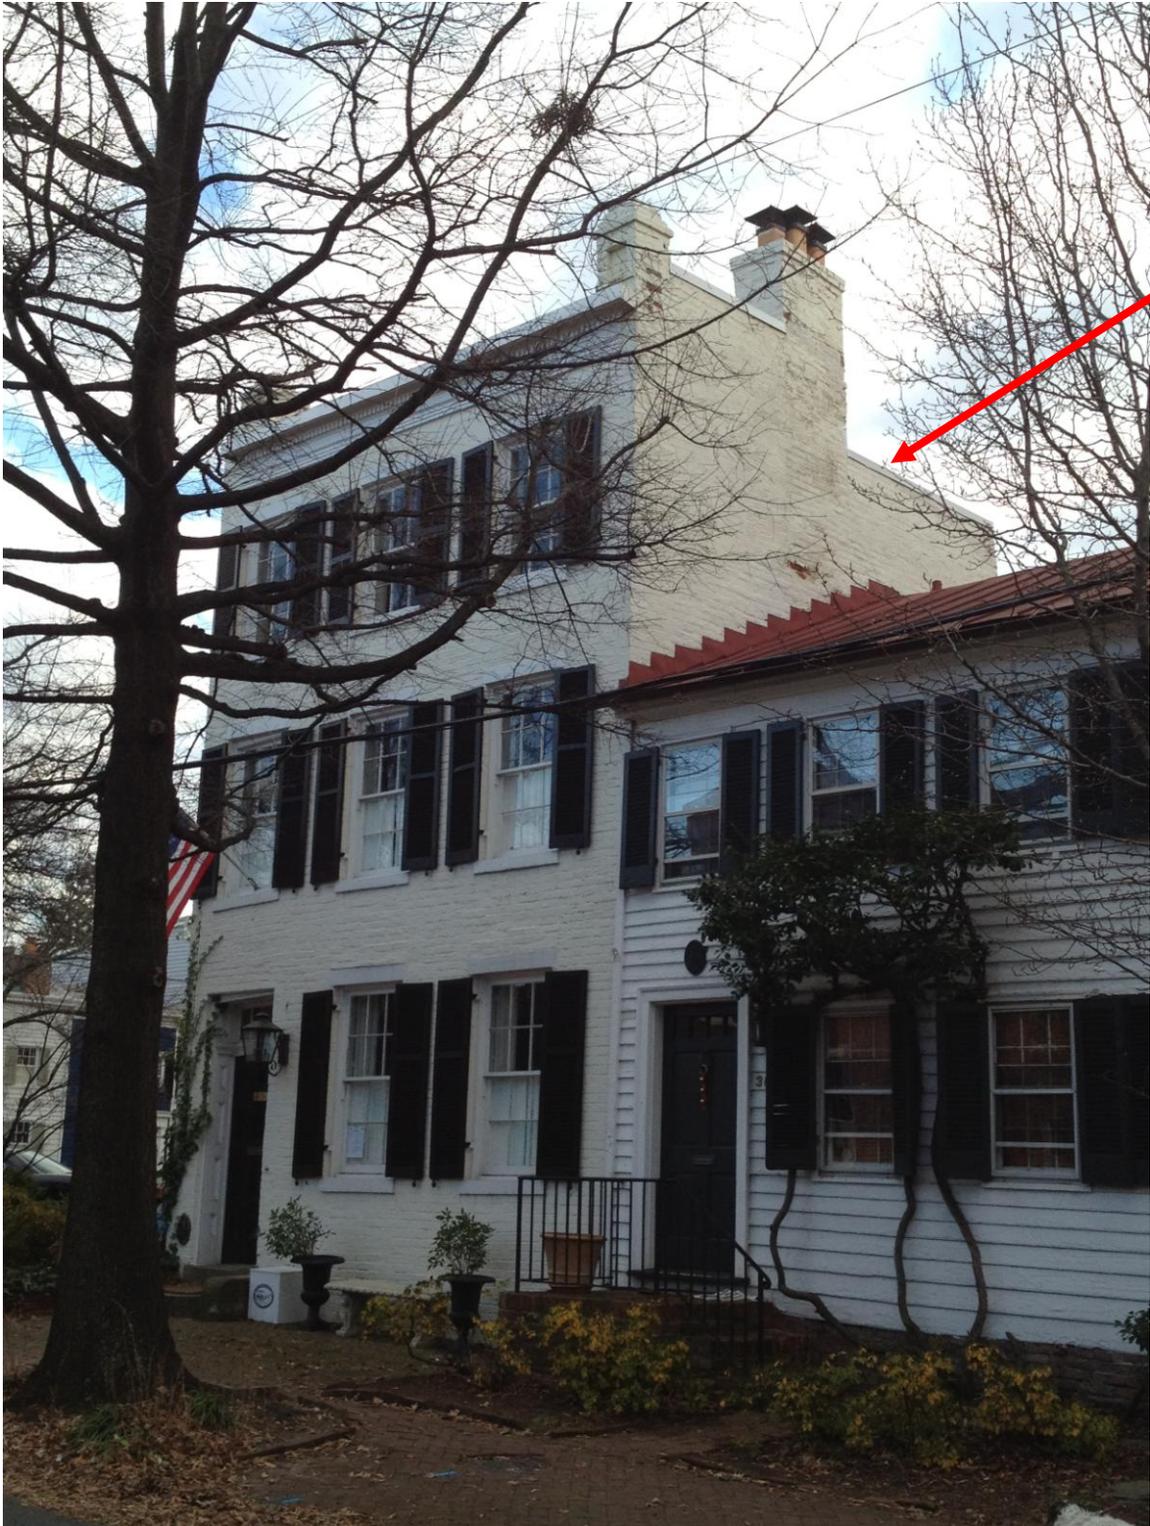
Figure 2: Front (north) and side (west) façade of 304 Duke Street.
Note: photo was taken after the partial demolition of the rear of the west parapet wall. Staff recommends approval of the current height shown in this photo.

Staffs' recommendation for the new height of the rear of the west parapet wall is to be reduced to a height that is comparable with the second or third tier of the east parapet wall. Since the contractor reduced the rear of the west parapet wall to this height, Staff recommends that the Board support the application, as submitted.

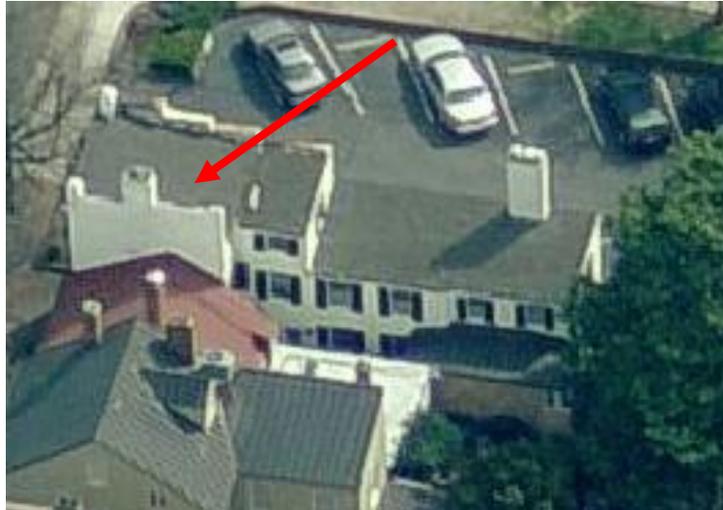
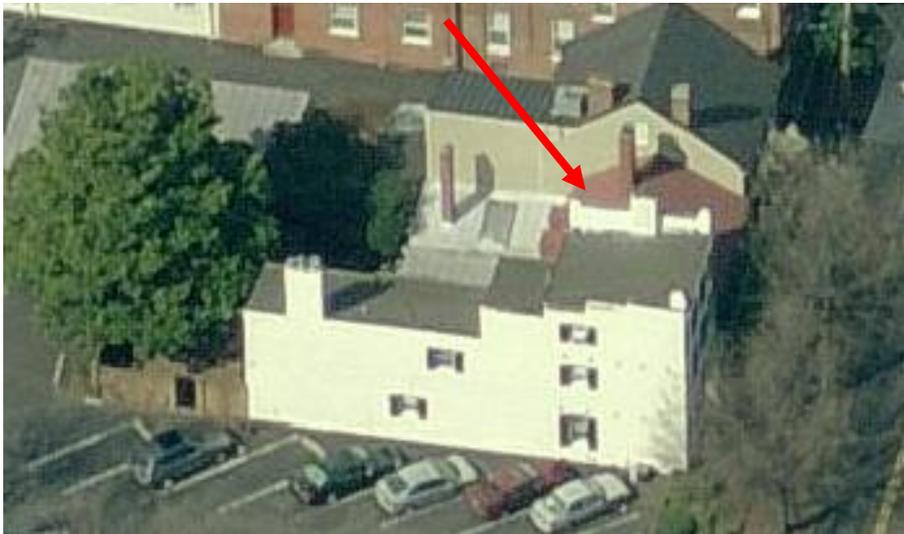
Figure 3: Aerial view of 304 Duke Street. Note the different parapets height/style on the west and east side.

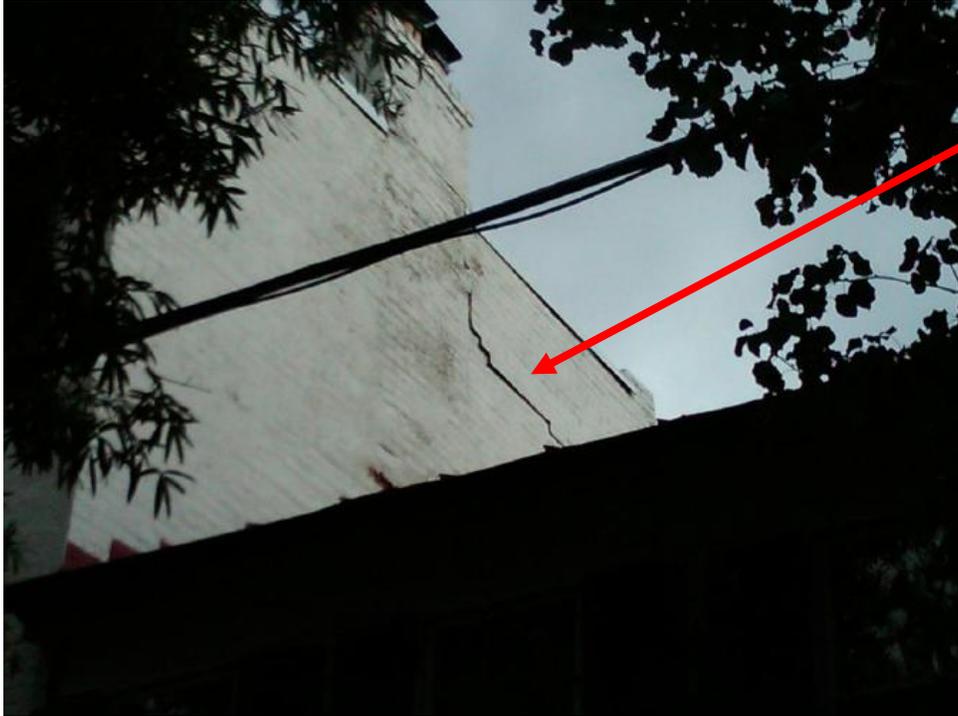
Figure 4: Earthquake damage to west parapet wall. Note former height of rear portion of parapet.

The applicant is requesting a Permit to Demolish to remove a portion of the rear west parapet wall (the portion that is south of the chimney) at 304 Duke Street. The parapet was damaged during the August 23rd, 2011 earthquake.

The subject parapet wall will be reduced in height by approximately 13 brick courses. This will reduce the height of the parapet by half, allowing it to line up with one of the tiers of the east wall's stepped parapet. The altered parapet will then be capped with a metal top to protect the exposed gap in the middle of the bricks and painted to match the remainder of the house.

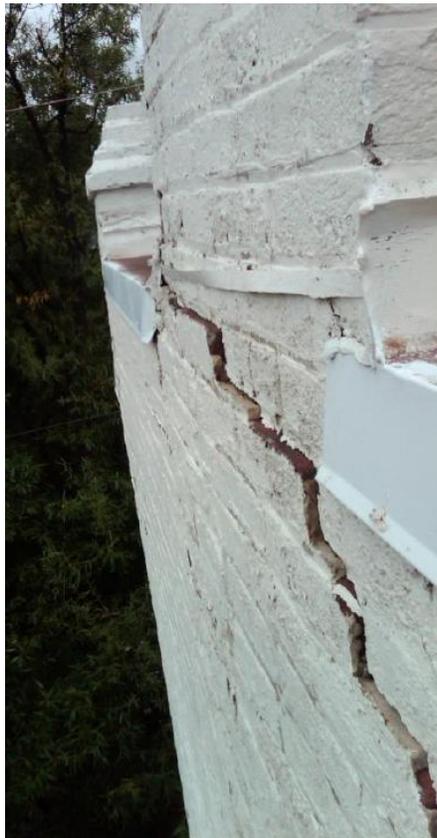
Figure 5: Close up of earthquake damage to west parapet wall.

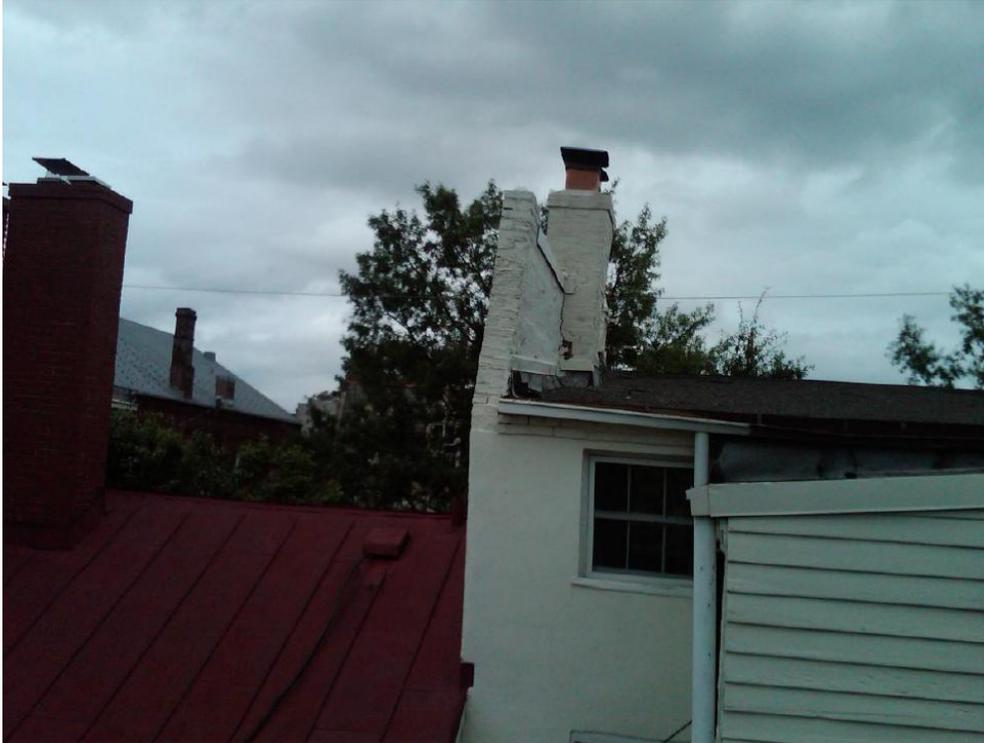
Figure 6: Before view of rear portion of west parapet wall (viewed from the south).

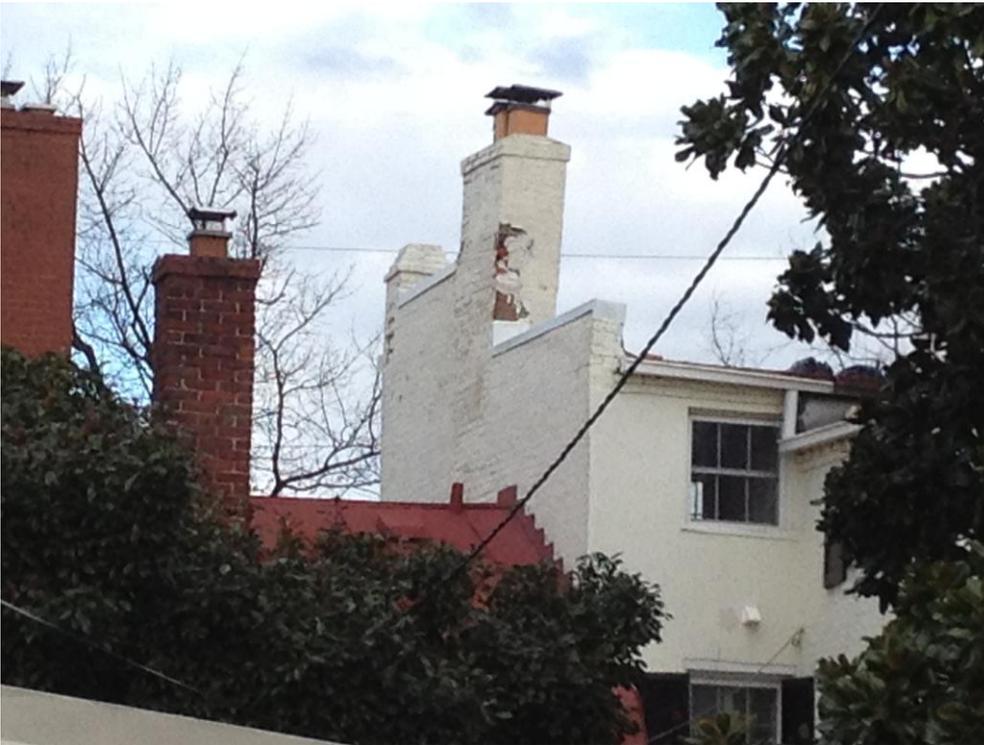
Figure 7: After view of rear portion of west parapet wall (viewed from the south).

applicant's contractor has dismantled the brick to a safe height. Due to the exposed gap in the bricks, the contractor has capped the parapet at its new height to ensure that future damage did not occur from the winter elements.

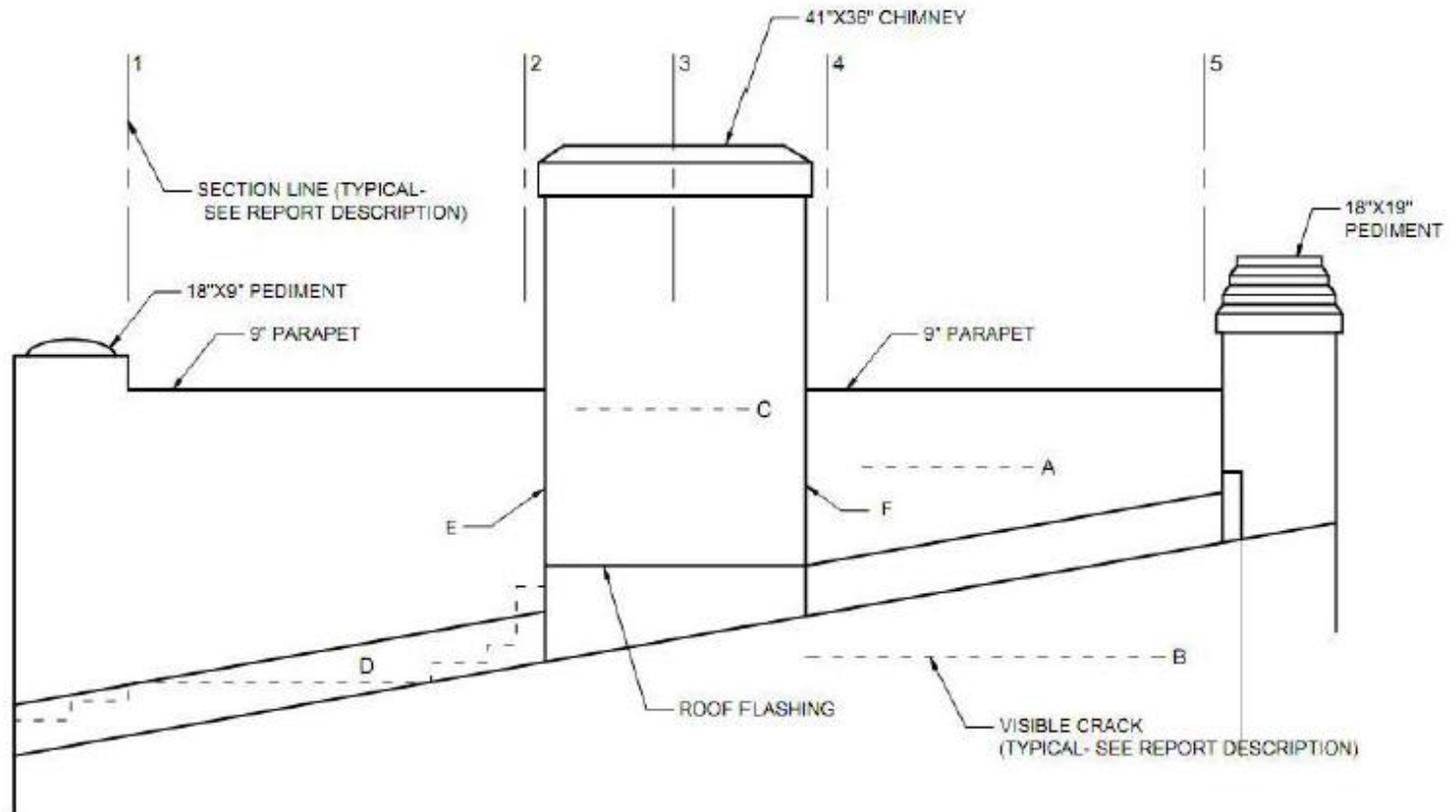
PROJECT NO. SA 47505554
 DRAWN BY SA SK-1
 DATE 10-7-11 SHEET 1 OF 1
 SCALE 1/2" = 1'-0"

Right Parapet and Chimney Elevation View from Roof

Figure 8: Elevation of damage to west parapet wall.
