City of Alexandria, Virginia

MEMORANDUM

SUBJECT: Consideration of a request for demolition at 428 North Columbus Street

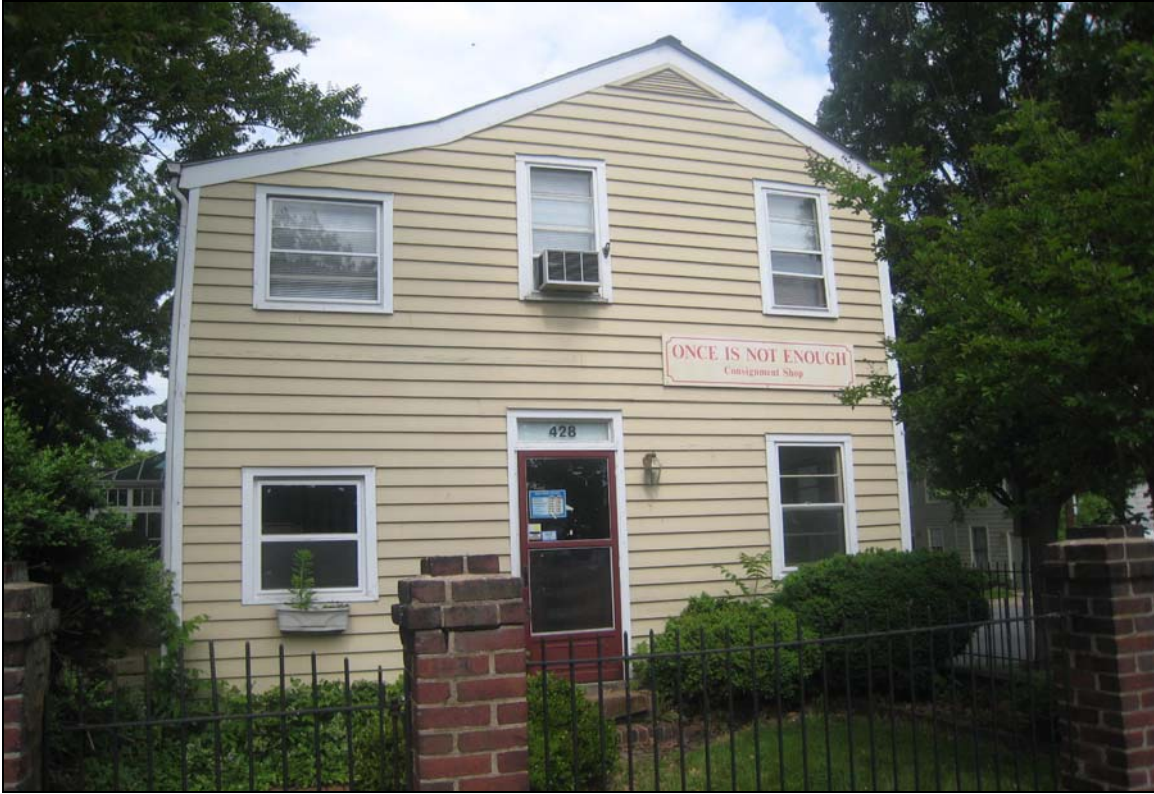
Figure 3. Front (east) elevation.

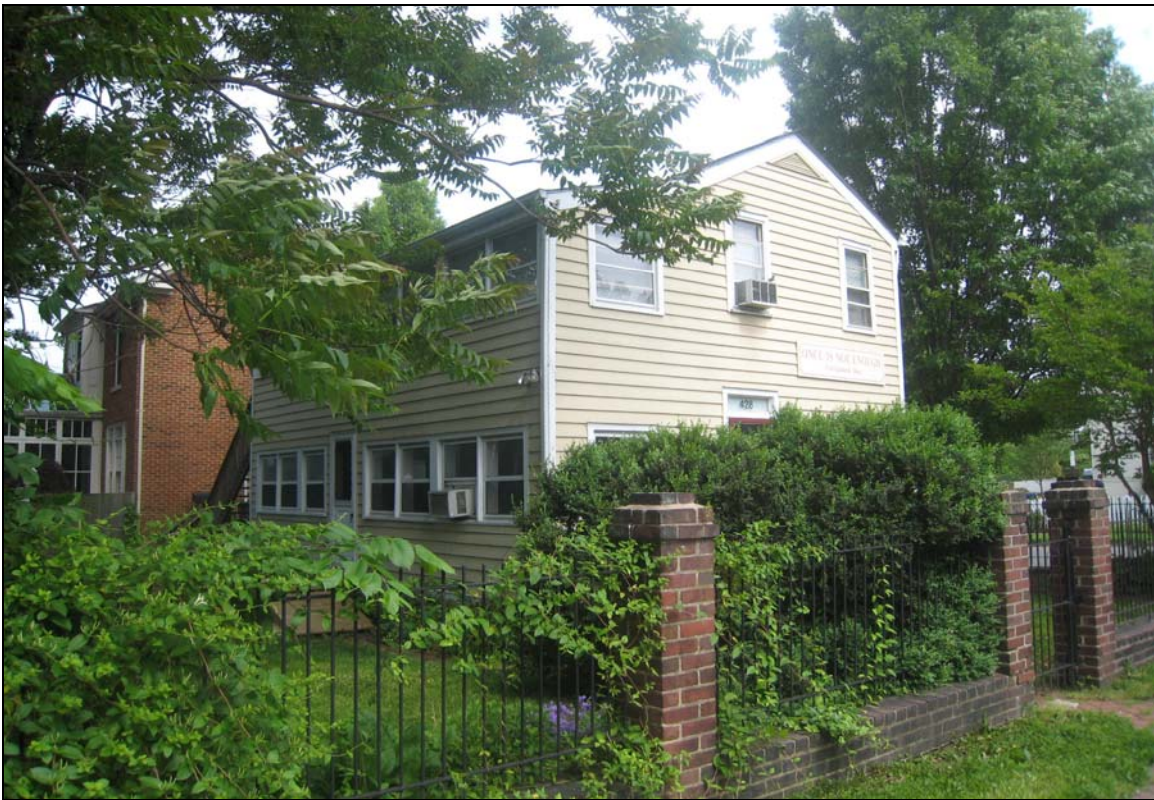
Figure 4. Oblique view showing enclosed porch on side (south) elevation.

The building located at 428 North Columbus Street is a simple, two-story, gable-fronted freestanding frame dwelling likely dating from the early to mid-nineteenth century. The building appears on the G.M. Hopkins Map from 1877. In this map, it is depicted as being located on the north property line and set back from the other three property lines. Immediately south of this property were two freestanding dwellings. The first Sanborn Fire Insurance Map depicts this block for the first time in 1896. In 1896, this building was a two-story frame building with a two-story frame porch on the south elevation and a one-story rear addition. By 1902, according to the Sanborn Fire Insurance Map, the house had been altered: the one-story rear addition was now a two-story ell attached to the main block, with a small one-story porch on the south elevation, and a new one-story rear addition was added to the west elevation. On the Sanborn Fire Insurance Maps from 1941 and 1958, the building is slightly modified from the original form but maintains the same form of a two-story main block with rear ell, and a two-story side porch on the south elevation. The current configuration of the building features the former open two-

story porch as an enclosed element. At the rear (west) elevation, a two-story addition has been added with an exterior stair. The property was subdivided in 1992 and a party wall was constructed between 428 North Columbus Street and a new building constructed at 808 Oronoco Street.

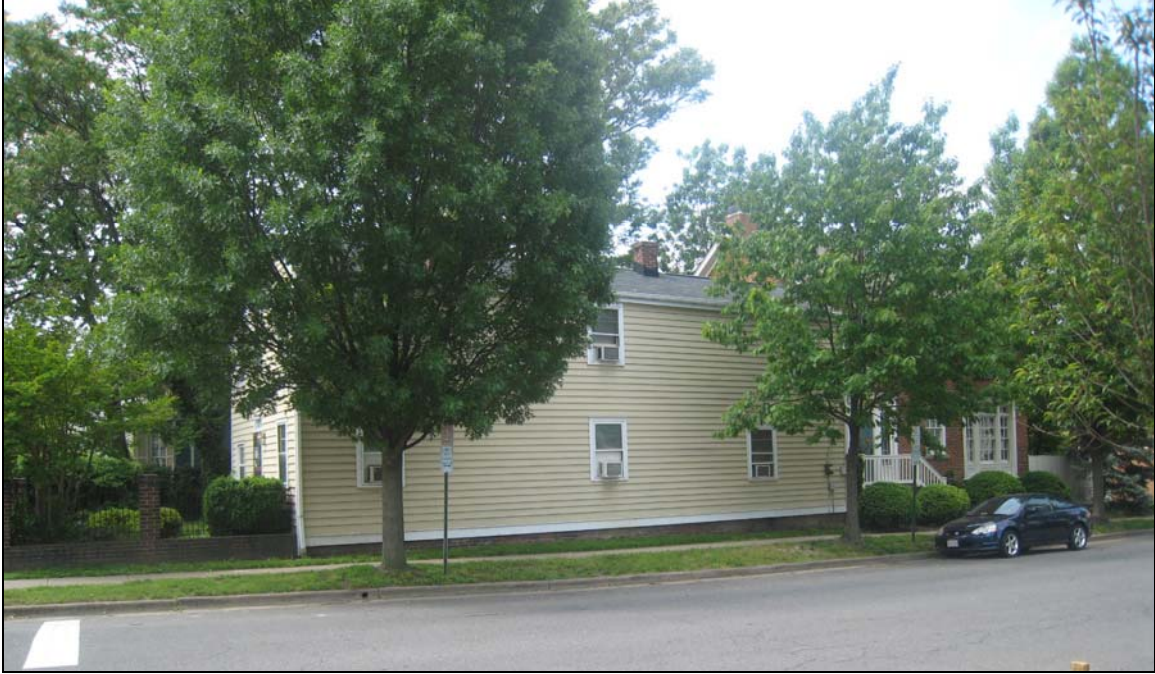
Figure 5. Oronoco Street (north) elevation.

- Subject property zoned CL, commercial low.
- Existing front façade facing Oronoco Street is built into the public right-of-way without City Council approval of a building encroachment.
- New construction cannot project into the public right-o-way without first obtaining City Council approval of an encroachment.
- Existing lot is substandard in lot area and lot width for a single-family dwelling. The existing lot is 2,524 square feet and the requirement is 5,000 square feet; the existing lot width facing North Columbus is 38.67 feet and the requirement is 50 feet. If applicant is approved for demolition, a new single-family dwelling may be built that complies with all CL requirements (FAR, yards and open space) within one year of the date of approval of the demolition.
- Grading plan required to build a new single-family dwelling. T&ES administers the grading plan process.
