Docket Item # 7
BAR CASE # 2009-0117

BAR Meeting
July 29, 2009

ISSUE: Alterations
APPLICANT: Valda Anderson
LOCATION: 123 South West Street
ZONE: CL / Commercial

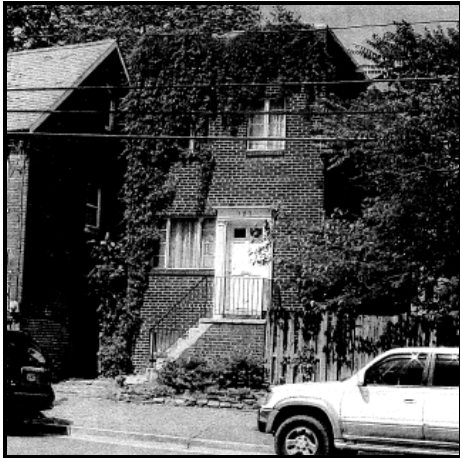
Figure 1. Photograph of front elevation

123 South West Street was designed and built with a minimalist aesthetic and is an example of the Modernist style in the Old and Historic Alexandria District. The house at 123 South West Street is similar in design to those designed by Joseph Saunders found on Gibbon Street, constructed in the 1950s. 123 South West Street and the houses on Gibbon Street are good examples of modernist architecture in the historic district that reflect the modernist architectural tradition in the United States and include such elements as proportional geometry, an absence of decorative ornament, the abstraction of design elements and factory metal casement windows. It is a rarity to find a building of this style and age in the district that maintains all of its original metal casement windows.

123 South West Street is a unique resource to the historic district in that it remains authentic to its original modern design without modification. Altering the facade by replacing the windows would greatly compromise the building’s historic integrity. It is

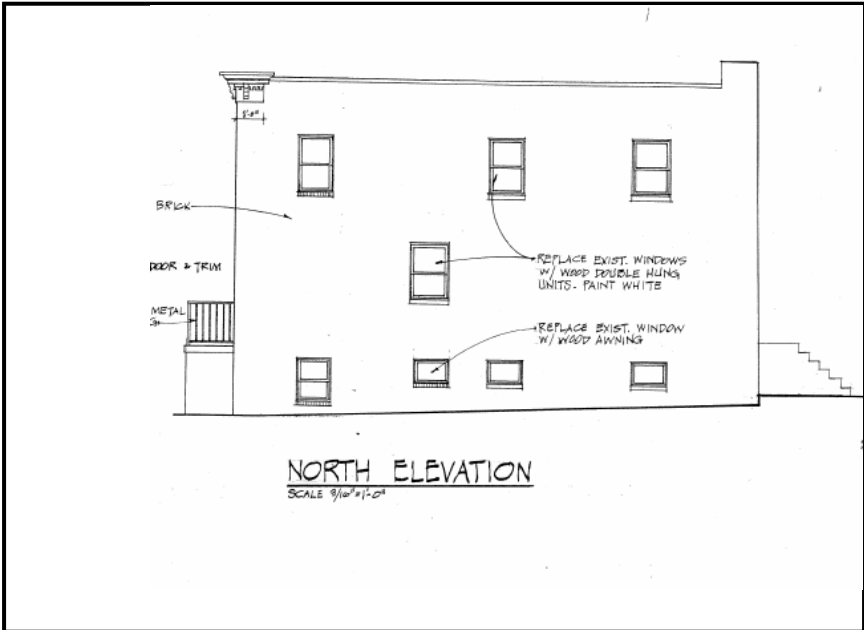
Figure 2. Drawing of proposed alterations on North Elevation

The applicant is requesting a Certificate of Appropriateness for alterations at 123 South West Street. On the front façade the applicant is proposing the replacement of three metal casement windows and one metal awning window. The applicant has selected casement windows in identical lite patterns to the existing windows for all three original metal casement windows and a wood awning window to replace the original metal awning windows. The proposed replacement casement windows are Weathershield double-glazed, true divided light wood windows. The muntin profile will be 7/8 inch. On the north elevation the applicant is proposing the replacement of five metal casement windows and three basement level metal awning windows. The applicant has selected wood, double hung replacement windows for all five original metal casement windows, and wood awning windows to replace all three original metal awning windows. The proposed double hung replacement windows are one-over-one, double-glazed wood windows.

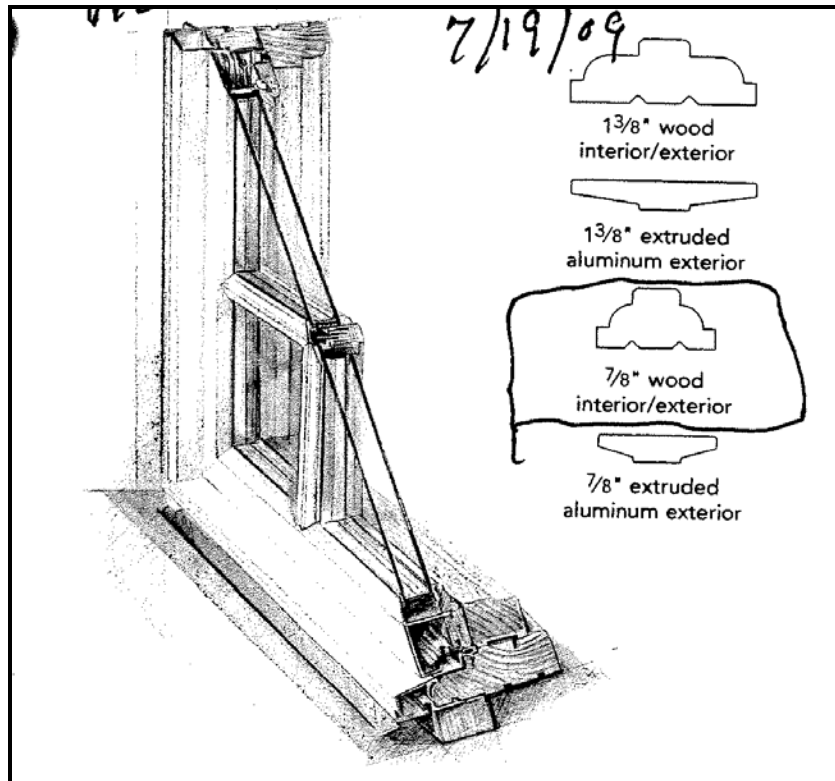
Figure 4. Specification sheet of proposed casement windows.

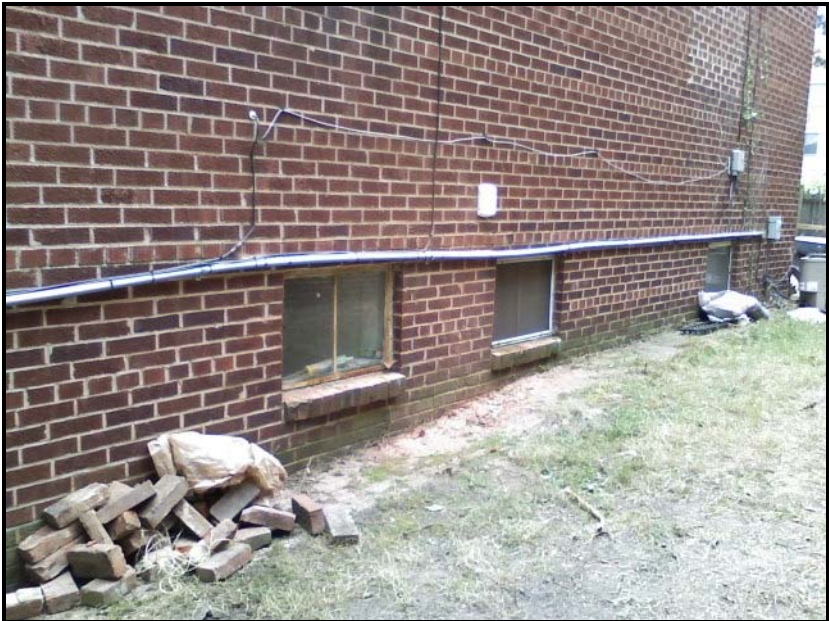
Figure 5. Photograph of basement windows on north elevation

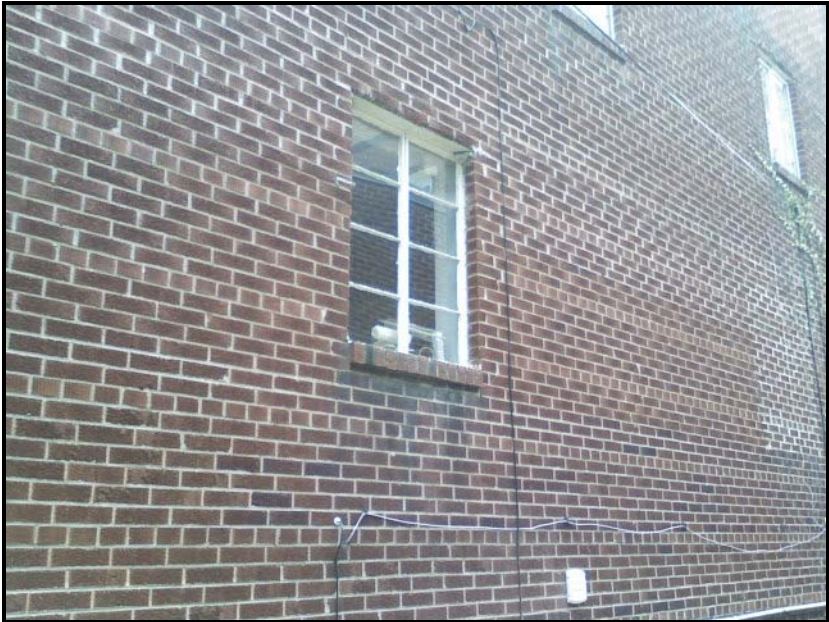
Figure 6. Photograph of casement windows on north elevation

The *Design Guidelines* clearly state that “a central tenet of the philosophy of historic preservation is that original historic materials should be retained and repaired rather than replaced. An informed and careful analysis of the existing condition should be made before any decision to replace historic materials is made.” Preservation Brief 13 by the National Park Service, US Department of the Interior, on the repair and thermal upgrading of historic steel windows states that, “In many cases, repair and retrofit of the historic windows are more economical than wholesale replacement, and all too often, replacement units are unlike the originals in design and appearance. If the windows are important in establishing the historic character of the building, insensitively designed replacement windows may diminish or destroy the buildings historic character.” In this situation, Staff finds the replacement of the original metal casement windows to be inappropriate due to the fact that they are the character defining features of the building. The brief continues to state “other elements in assessing the relative importance of historic windows include the design of the windows and their relationship to the scale, proportion, detailing, and architectural style of the building...and less elaborate windows can also provide strong visual interest ...particularly in simple, unadorned industrial buildings.” Metal casement and wood double hung windows are not synonymous and replacing one for another as indicated in this application would destroy the building’s historic character. In addition, choosing one style of window for a front facade and another for a side elevation to alleviate cost violates the historic integrity of the district. It is the opinion of Staff that the windows appear to be in a condition in which they can be repaired and retained. According to the National Park Service, “moisture is the primary cause of corrosion in steel windows,” the solution for which is to “add weather-stripping.” This would also make them more energy efficient.
