Docket Item # 5 BAR CASE #2010-0119

BAR Meeting June 16, 2010

ISSUE:	Alterations
APPLICANT:	Old Town Windows and Doors for Todd Hollis
LOCATION:	724 Gibbon Street
ZONE:	RB/Residential

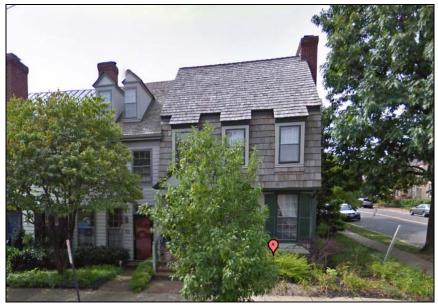
Figure 1: Photograph of Existing Windows – Front Elevation/Gibbon St.

The applicant is requesting approval to replace a total of 14 windows; five on the front of the home facing Gibbon Street and six on the side elevation facing South Columbus Street, and three on the rear elevation. The existing windows are single-glazed, double-hung, 9/9 and 6/6 wood windows with exterior storms. The applicant is requesting approval of Marvin Ultimate Wood Double Hung double-glazed windows with 7/8" muntins. The proposed windows will be simulated divided light with an interior spacer and an identical light pattern to the window they are replacing.

724 Gibbon Street was built in **1979**. This two-story frame, Colonial Revival townhouse is detailed with oversized cedar shingled Mansard style roof at the second story, Masonite siding, 9/9 wood, single glazed, true-divided light windows on the first level and 6/6 wood, single glazed, true-divided light windows on the second. The front door is a raised panel door flanked by multi-light sidelights and capped with a five-light transom.

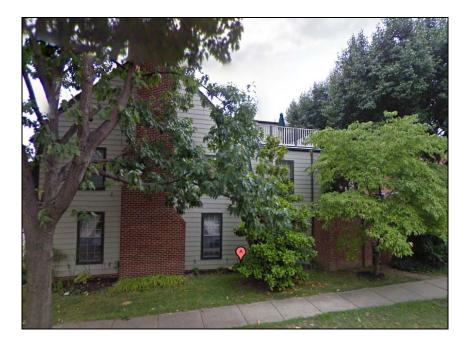
Figure 2: Photograph of Existing Windows - Side Elevation/South Columbus St.

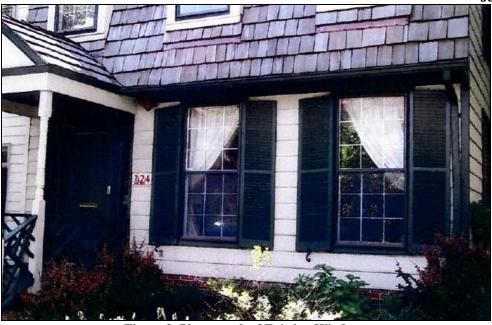
Figure 3: Photograph of Existing Windows

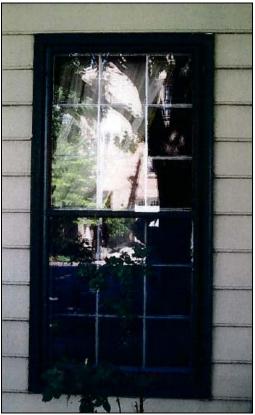
Figure 4: Photograph of Existing Window
