Docket Item # 3 BAR CASE #2010-0152

**ISSUE:** Alterations

**LOCATION:** 413 Green Street

The applicant is requesting approval of a Certificate of Appropriateness for replacement windows at 413 Green Street.

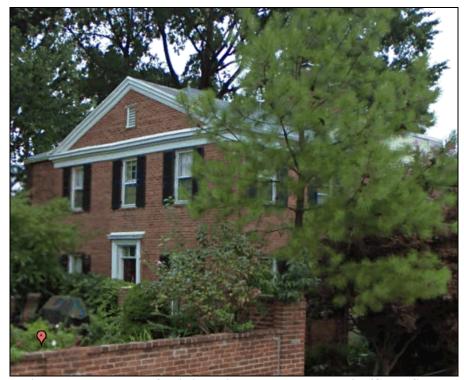
Figure 1: Photograph of Existing Windows – Front Elevation/Green Street

The applicant is requesting approval to replace a total of 13 windows; four on the front of the home facing Green Street, five on the side elevation and four on the rear elevation. The existing windows are single-glazed, double-hung, 6/6 wood windows with exterior storms. The applicant is requesting approval of Marvin Ultimate Wood Double Hung Magnum double-glazed windows with 7/8" muntins. The proposed windows will be simulated divided light with an interior spacer and an identical light pattern to the window they are replacing.

423 Green Street was built in **1942**. This two-story masonry, Colonial Revival townhouse is a side entry townhouse with a side gable roof facing the street and 6/6 wood, single glazed, true-divided light windows flanked with operable two-paneled louvered shutters. The front door is a raised panel door detailed with a simple surround.

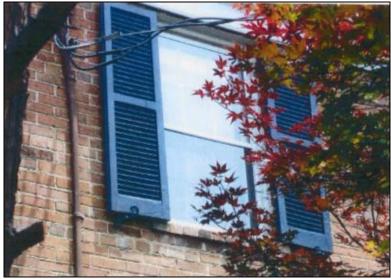
Figure 2: Photograph of Existing Windows

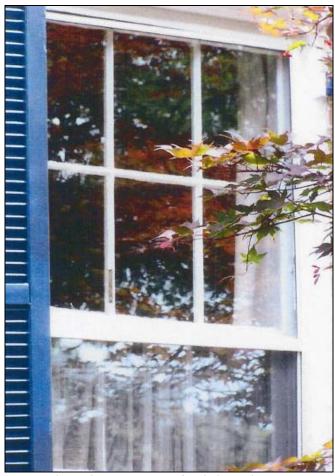
Figure 3: Photograph of Existing Windows

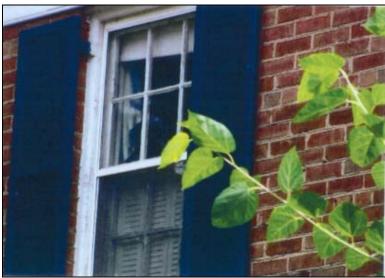
Figure 4: Photograph of Existing Windows

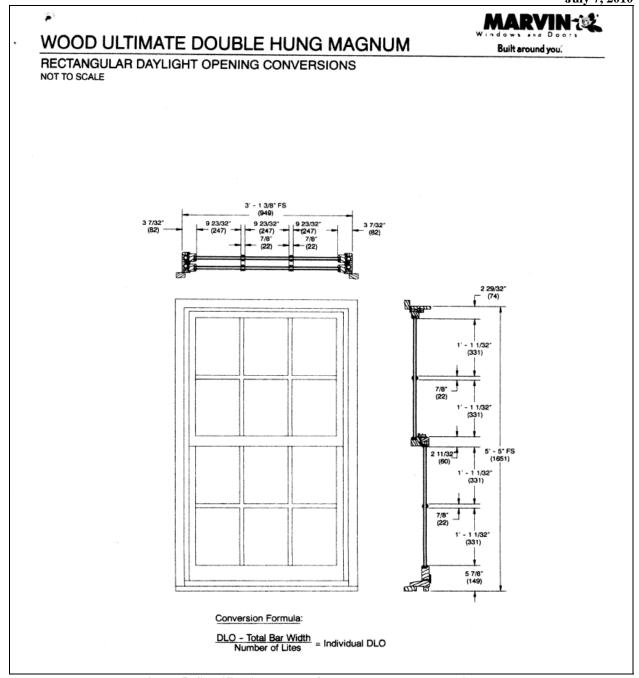
Figure 5: Specifications sheet of proposed replacement windows

Therefore, given the age of the townhouse and the fact that the existing 6/6 light pattern and putty glazed muntin profile and size will be retained, Staff does not object to the installation of painted wood double-insulated windows, with simulated divided light, and dark colored interior spacer bars. Staff finds the proposed replacement windows appropriate and reminds the applicant that as of June 1, 2010, window replacement requires a building permit within the historic districts.

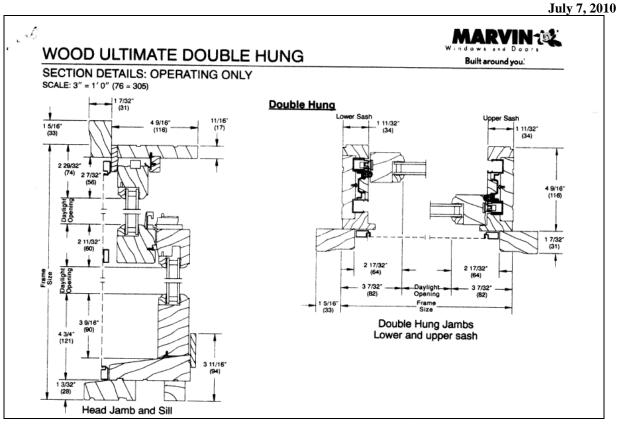
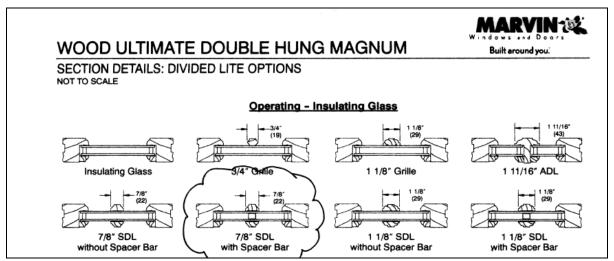
Figure 6: Specifications sheet of proposed replacement windows
