Docket Item # 4
BAR CASE #2010-0324

BAR Meeting
December 1, 2010

ISSUE: Alterations (HVAC Screening)

LOCATION: 120 South Fairfax Street

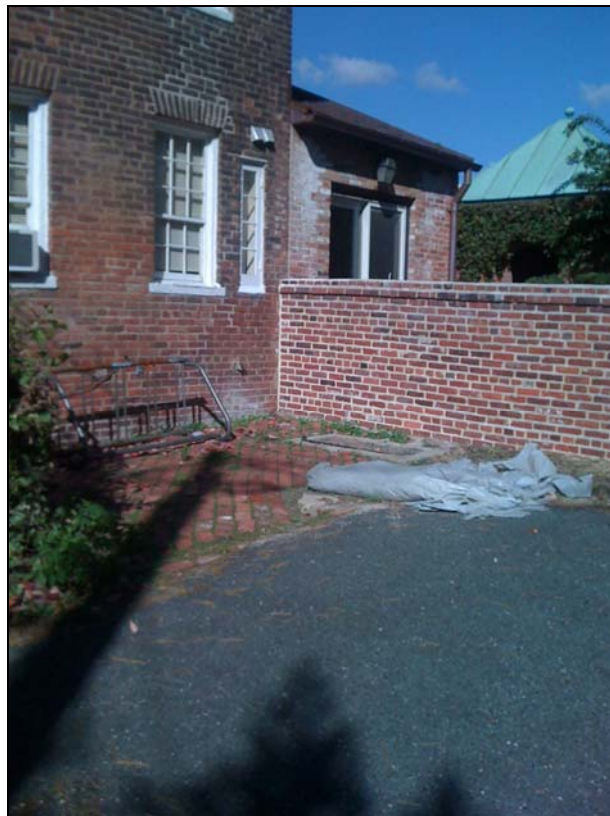
Figure 4. General location (on brick) of HVAC condenser units and screening.

In this case, the HVAC condenser units and associated screening are located in the least obtrusive location possible on this property. When the applicant originally approached Staff, the proposal was to install three of the five units along the southern elevation of the building adjacent to the alley. In this proposal, the units would have been highly visible from South Fairfax Street through the existing iron fence with brick piers and the units would have visually destroyed what is currently a charming urban garden area. Staff worked with the applicant to find a more appropriate location on the rear of the property. While it is never ideal to install five HVAC condenser units in one location, Staff recognizes the needs of modern HVAC equipment for a building of this size and notes that it will allow the existing window units to be removed. Further, the proposed location of the units and screening is adjacent to a parking area and minimally visible from South Fairfax and South Lee streets. Staff recommends that the fence design be further refined through the addition of corner posts with decorative post caps and that the fence be painted a dark red or green color to recede.

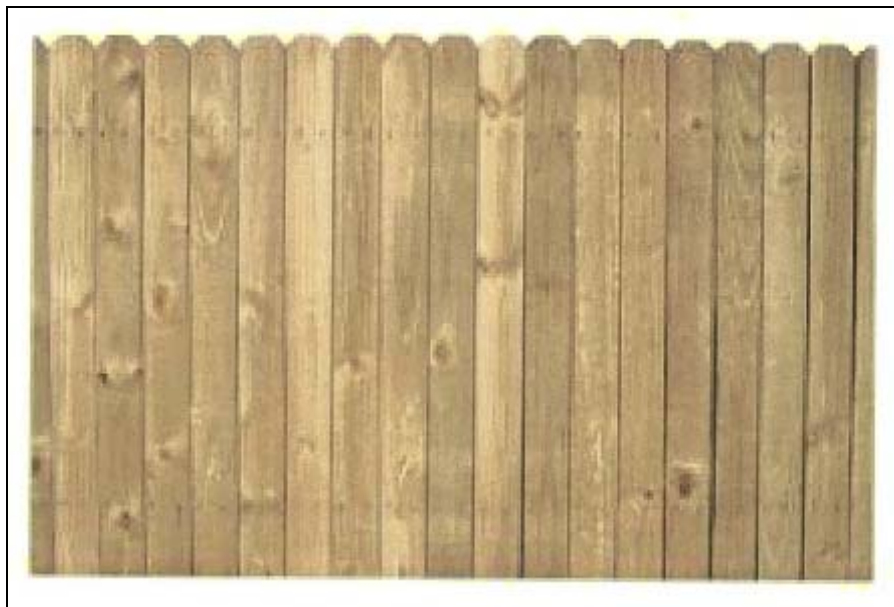
Figure 6. Proposed fence design.

The applicant is requesting approval of a Certificate of Appropriateness for the installation of a fence to screen five proposed HVAC condenser units at the rear of the property at 120 South Fairfax Street. The proposed fence will be a four foot tall board-on-board wood fence and will be located in an area between the existing parking area and the rear of building. The maximum size of each condenser unit will be 37 inches (width) by 34 inches (depth) by 45 inches (height). Some of the existing vegetation will be removed to accommodate the units and fence. Although the alley is private, the screening will be minimally visible from South Fairfax and South Lee streets.
