Docket Item # 5  
BAR CASE #2010-0316

**ISSUE:** Alterations (Door Replacement)

**LOCATION:** 111 Pommander Walk Street

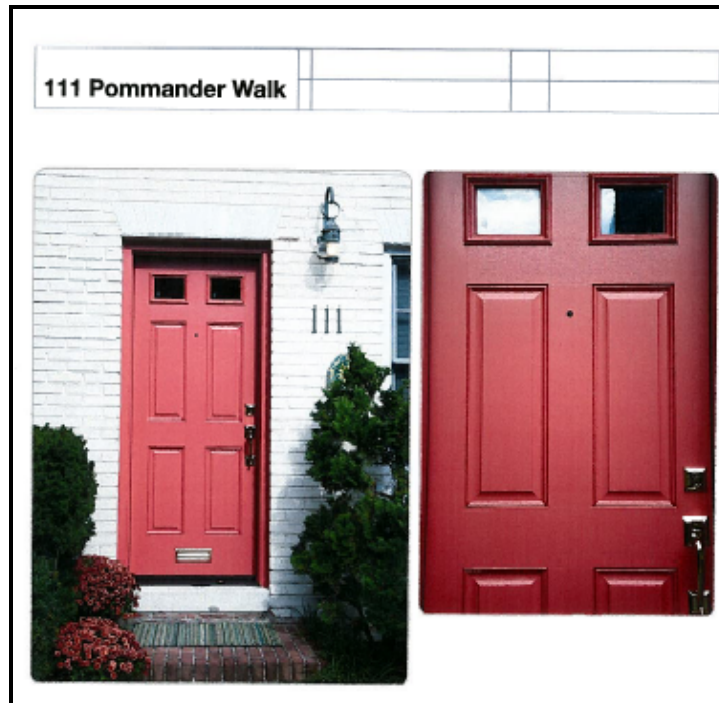
Figure 1: Fiberglass door at 111 Pommander Walk Street

The applicant is requesting after-the-fact approval of a Certificate of Appropriateness for a painted fiberglass door at 111 Pommader Walk Street. The six panel, field painted fiberglass door has glazing in the two upper panels. The applicant has stated that the past two wood doors installed by the applicant have warped and cracked due to the southern exposure of the townhouse. The smooth fiberglass door was manufactured by Therma-Tru.

The Board has maintained in the past that a front door is regularly used by residents and their guests and should be constructed of natural materials because this tactile quality is important in a historic district – even on modern buildings. However, Staff conducted a site visit to the property and found the smooth fiberglass door to be nearly indistinguishable from a field painted wood door. Although Staff has been told that there are a number of other townhomes in this immediate area that have fiberglass doors, they are visually difficult to locate when they have been field painted. Even the “stained” woodgrain fiberglass doors now promoted by some manufacturers are difficult to distinguish in the field, although these would not be recommended by Staff because stained wood doors were not historically common until clear finishes that could withstand weather were invented in the 20<sup>th</sup> century. From what research Staff has done thus far, high-quality fiberglass doors can be molded to have the same crisp lines and panels as wood doors, yet have greater lifespan and increased thermal efficiency. Because they are filled with foam, they have a density and sound very similar to wood when one knocks on them. Staff also notes that high quality versions of these doors are not inexpensive and should be more durable than doors constructed of modern, fast growth

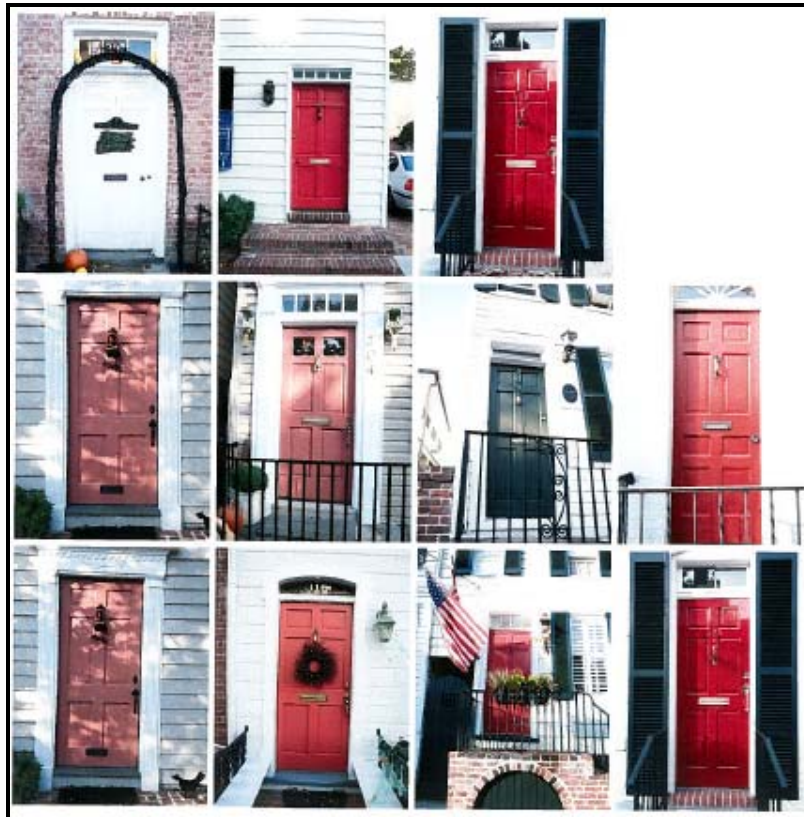
Figure 2: Photos of other six panel doors in the historic district.

Given the age of the building and the variety of door styles and materials within the late 20<sup>th</sup> century Pommander Walk development, Staff believes the proposed 6-panel, Colonial Revival style door is high quality and compatible with the other townhouses in the development. A site visit to the development reveals a significant variety of door styles (4-panel, 6-panel, imitation leaded glass), only a few of which were approved by the Board. Furthermore, the Board has already approved the use of synthetic materials within the development when they approved an AZEK door surround at 105 Pommander Walk Street in 2006 (BAR Case #2006-0295).
