Docket Item # 2
BAR CASE #2010-0293

BAR Meeting
January 19, 2011

ISSUE: Signage
APPLICANT: Capital One Bank
LOCATION: 500 South Washington Street
ZONE: CD/Commercial

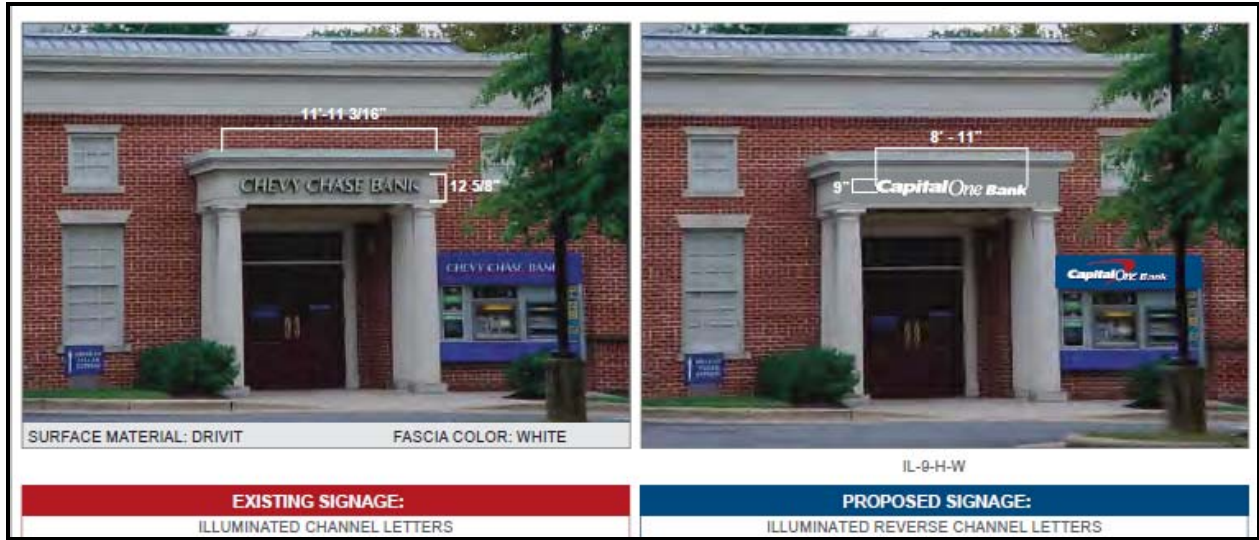
Figure 1: Previous Chevy Chase Bank sign and proposed Capital One Bank sign – Wilkes Street.

- The existing signs above the Washington Street and Wilkes Street entrances will be removed and new reverse channel white letters (halo lit) with the bank logo (minus the red “swoosh”) will be installed. The Washington Street sign will measure 14” by 13’ 10 3/4” (approximately 16.2 square feet). The Wilkes Street sign will measure 9” by 8’11” (approximately 6.6 square feet).

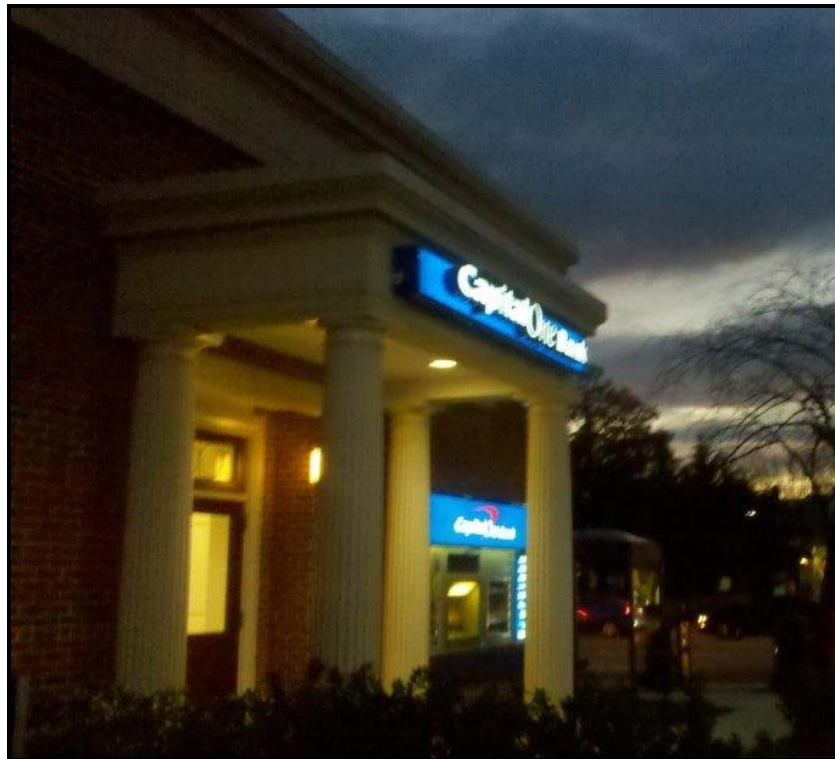
Figure 2: Photo of existing, unapproved Capital One Bank signs at the Wilkes Street entrance.

- Two internally illuminated channel letter signs installed on an illuminated box on the frieze above the Washington Street and Wilkes Street entrances to the bank. The total square footage of these signs is approximately 32 square feet.
- Bank logos on the illuminated sign bands above the three ATM machines.
- A bank logo sign on the illuminated Teller Express box located adjacent to the drive-thru ATM machine which faces South Washington Street.
- A new directional sign and multiple customer parking signs with a blue background and the bank logo.
- New blue clearance signs over the two ATM drive-thru kiosks.
- Two new Capital One Bank door graphics, with the hours of operation (another two Chevy Chase Bank door graphic were removed and not replaced).

While the applicant was given clear direction that the installation of signs required BAR approval and a sign permit, the bank none-the-less installed the existing Capital One Bank signs. Staff, and the National Park Service, find these signs to be too large, too bright and generally inappropriate for this prominent Greek Revival style bank building on the George Washington Memorial Parkway. After the BAR application was submitted, the applicant worked closely with Staff and understood that the installed signs were unlikely to gain Board approval. A November 17th, 2010 letter from the National Park Service also concurred that the signs were excessive and inappropriate. However, with a few exceptions, Staff supports the revised application. The National Park Service also submitted a letter of support on January 10th, 2011, commending the applicant for the revised sign package.

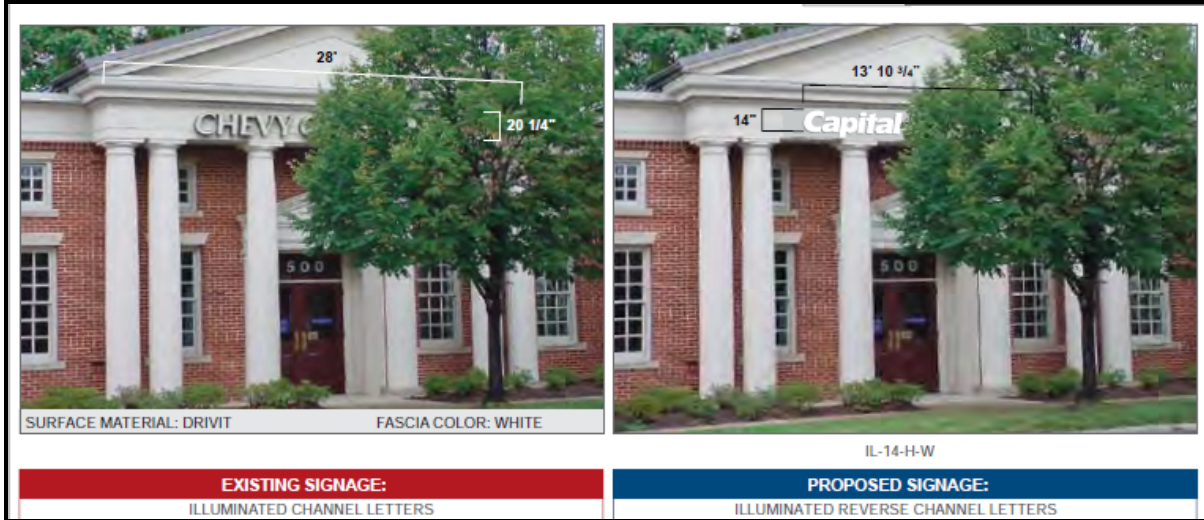
Figure 3: Previous Chevy Chase Bank sign and proposed Capital One Bank sign – Washington Street.

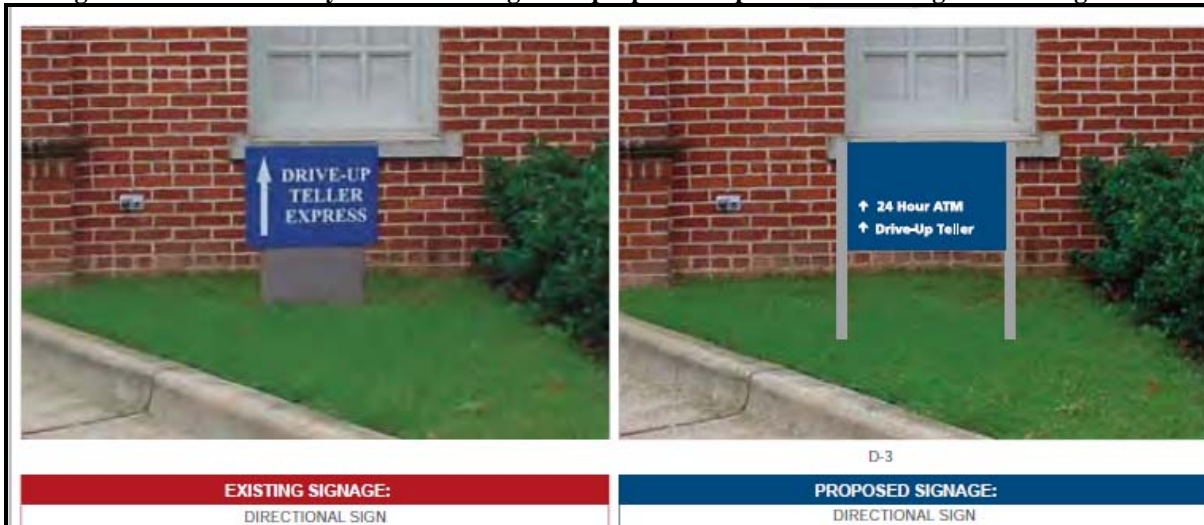
Figure 4: Previous drive-up teller express sign and proposed directional sign.

- The Capital One Bank logo installed on the directional sign next to the Wilkes Street entrance, and on the customer parking signs throughout the parking lot, will be removed and only the relevant information – on a blue background – will be provided.

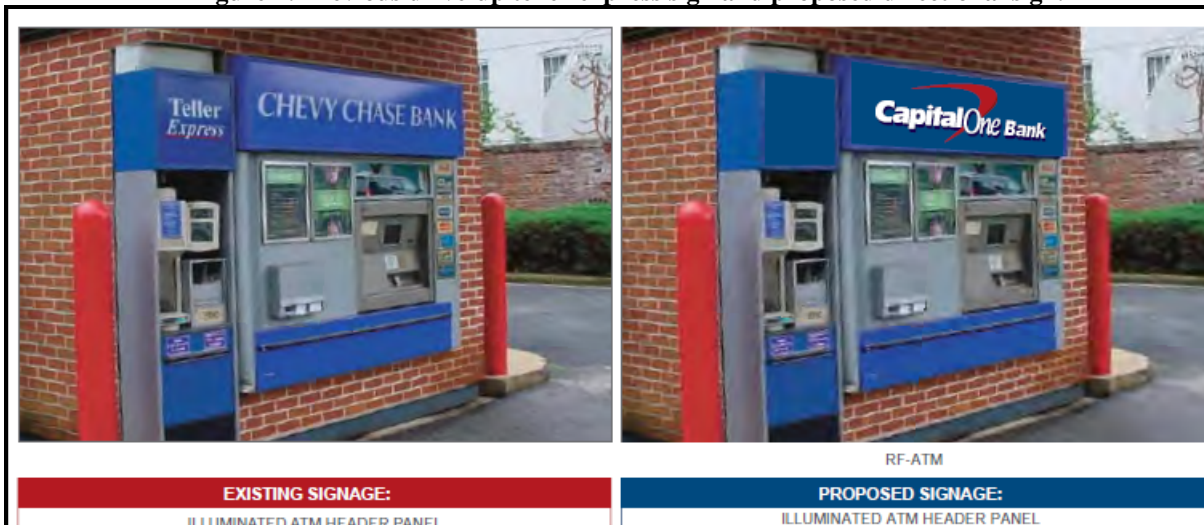
Figure 5: Previous and already installed ATM header sign – drive-thru kiosk (1).

- No changes are proposed to the already installed blue clearance signs above the drive-thru ATMs, the three ATM sign bands or the door graphics.

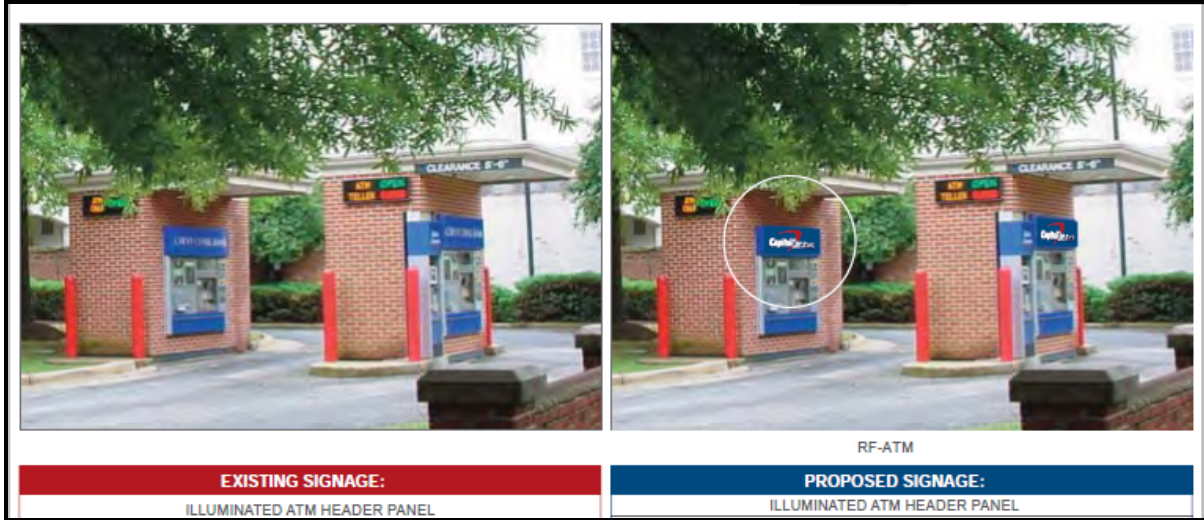
Figure 6: Previous and already installed ATM header sign – drive-thru kiosk (2).

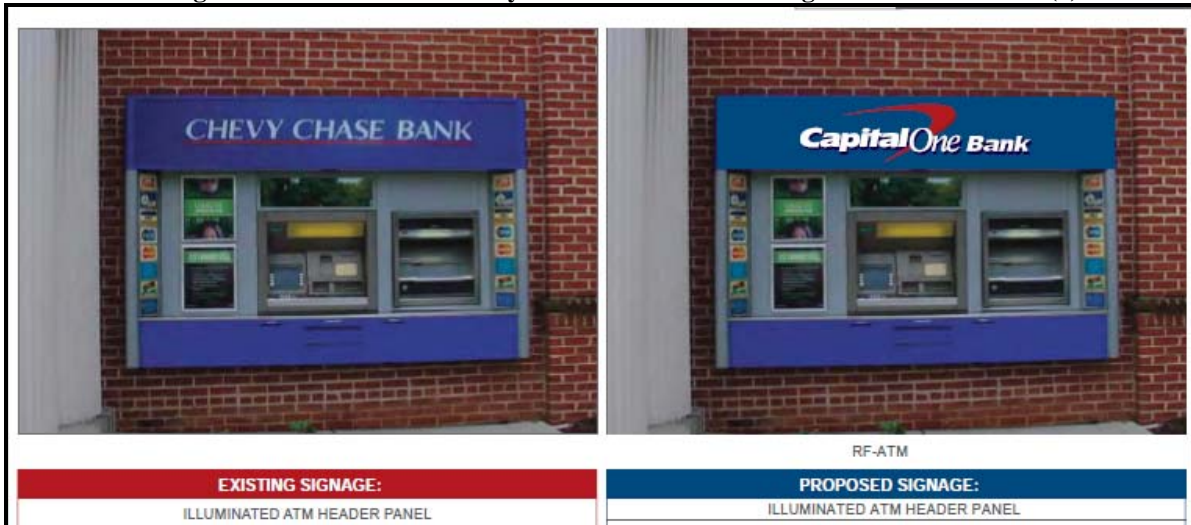
Figure 7: Previous and already installed ATM header sign – Wilkes Street walk up.

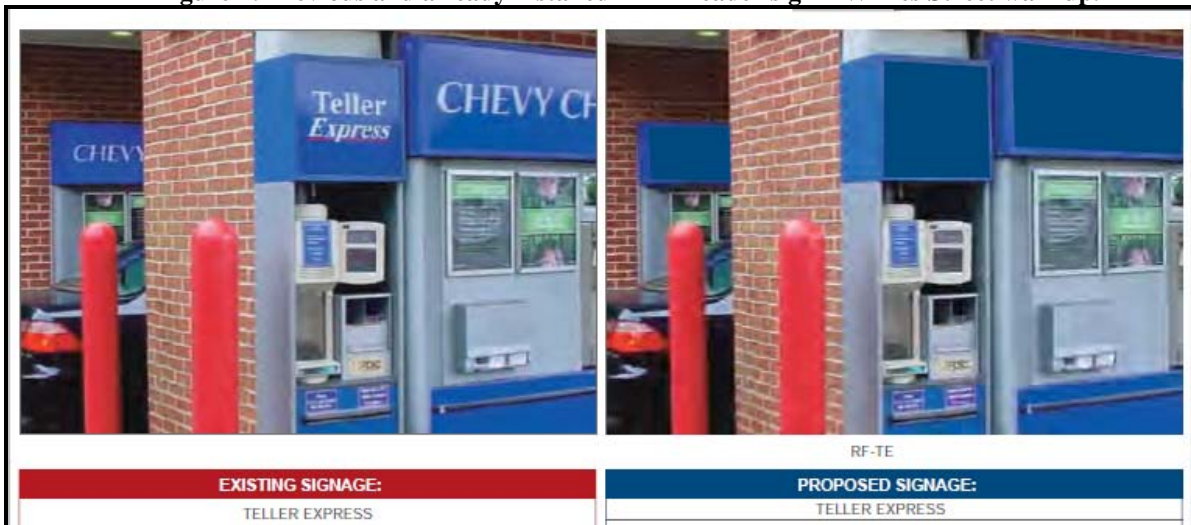
Figure 8: Previous and proposed Teller Express sign (blank).

- The teller express box adjacent to the westernmost ATM drive will be resurfaced with a solid blue insert (the Capital One Bank logo will be removed).

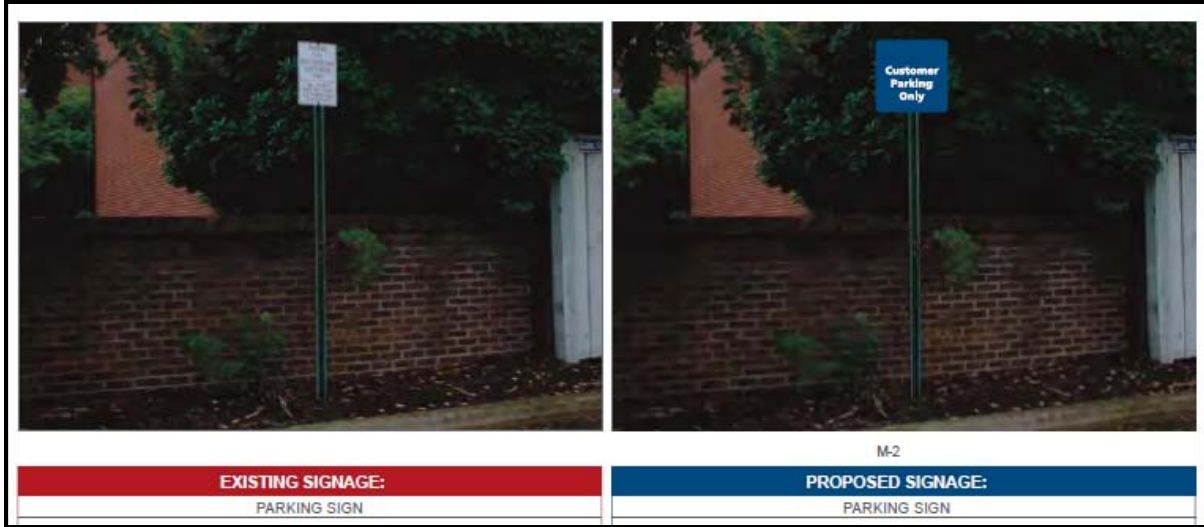
Figure 9: Previous and proposed customer parking signs (multiple locations).

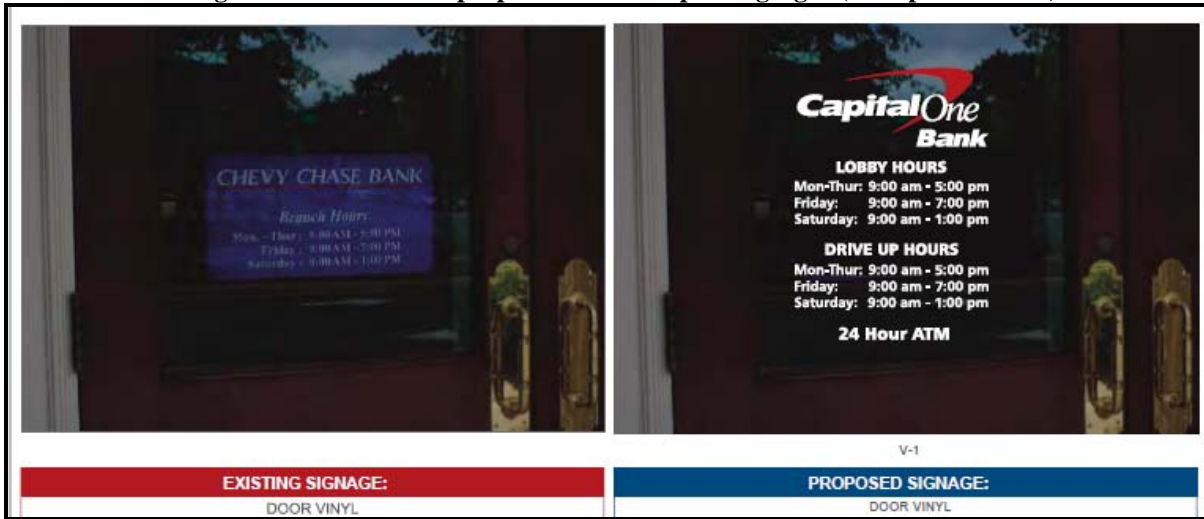
Figure 10: Previous and already installed door graphics on two entrance doors.

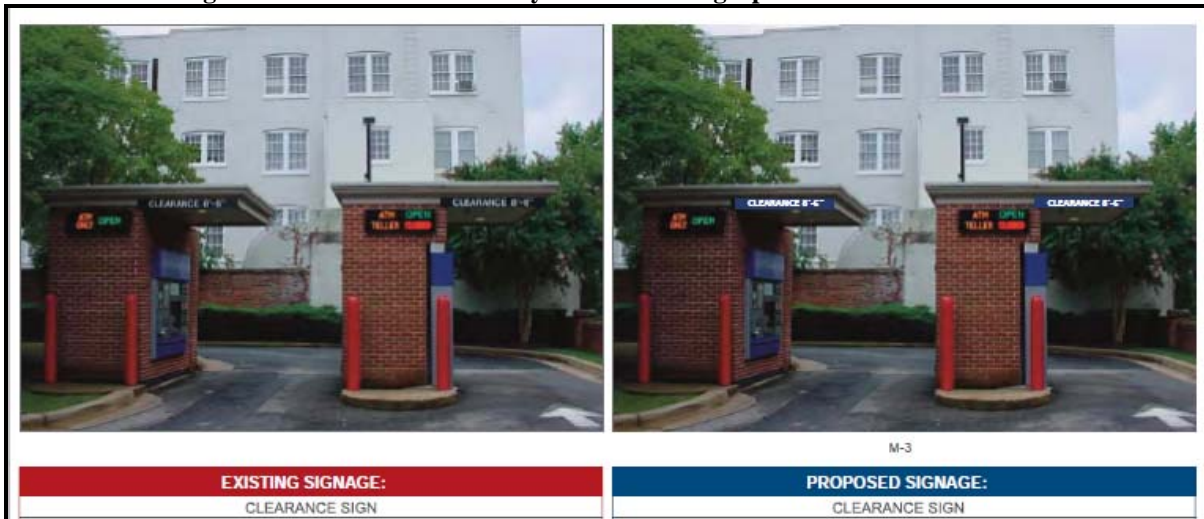
Figure 11: Previous and already installed clearance signs over two ATM drive-thru kiosks.

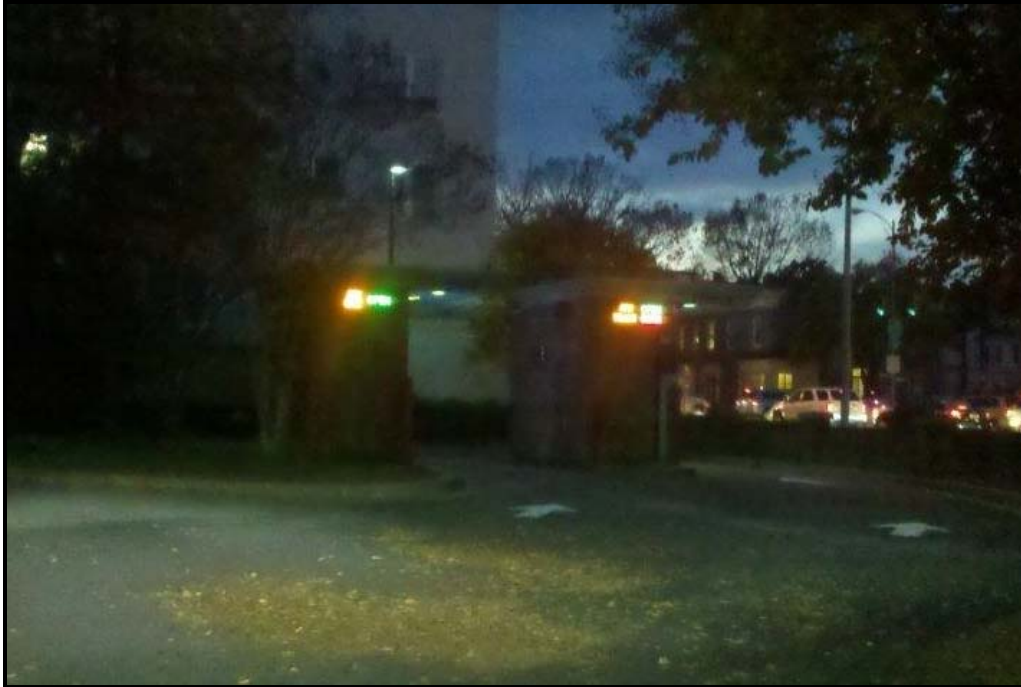
Figure 12: Photo of existing ATM/Teller open signs.

1. that the existing ATM/Teller LED/neon “open” signs are removed; and,
2. that the existing and unapproved Capital One Bank signs are replaced with the approved bank signs within 60 days.

Although never explicitly approved by the Board – "other signage normally associated with ATMs" – Chevy Chase Bank installed two ATM/Teller open/closed neon-like LED signs on each drive-thru ATM kiosk. Although the applicant does not propose any change to these signs, Staff finds them particularly egregious because of their visibility from South Washington Street. It is generally assumed that ATMs are open at all times and that remote teller machines are open during normal business hours (it is also confirmed on the Bank's door graphics, which list the teller hours of operation and notes that the ATMs are open 24 hours). Therefore, Staff believes that these signs are unnecessary and should be eliminated.

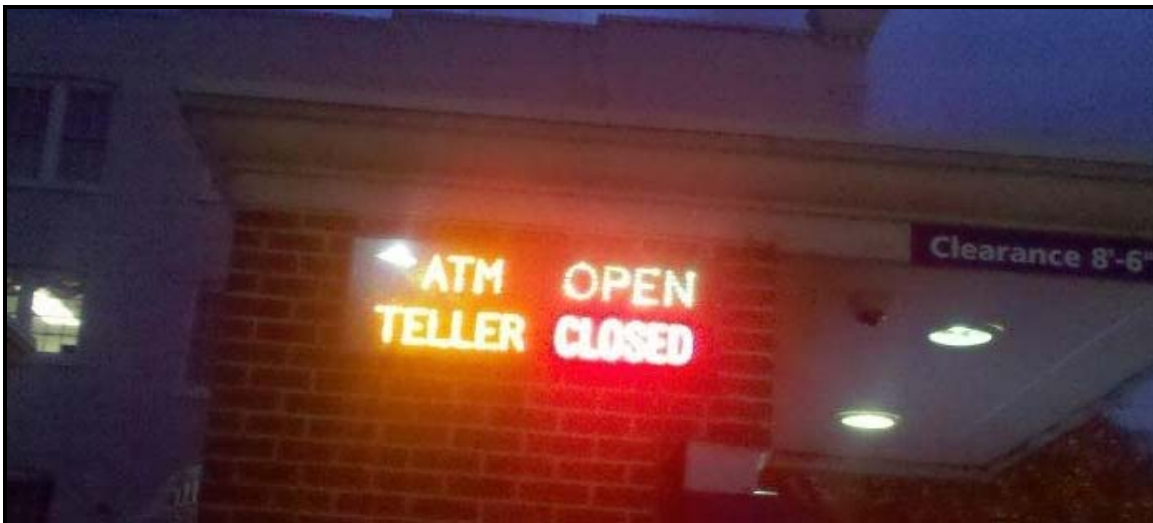
Figure 13: Close up photo of existing ATM/Teller sign.
