Fire Station 207

DRAFT REPORT

Alexandria Fire Department - Alexandria, Virginia

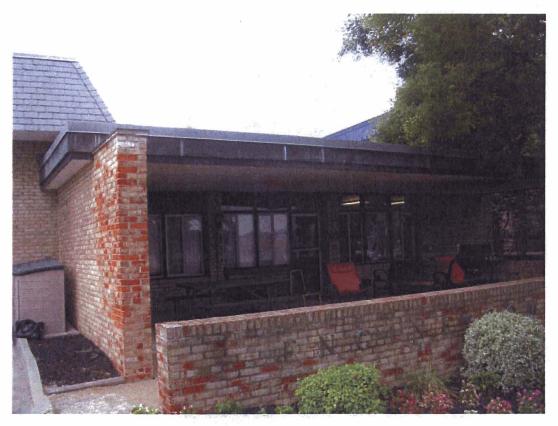
Built in 1963 the facility is located on Duke St and has very limited parking at the rear of the facility. The fire station construction is brick masonry construction. Roofing consists of EPDM construction with a mansard style slate roof over the vehicle bay area. A video study of the sanitary line should be conducted to determine the extent of sewer issues at the facility.

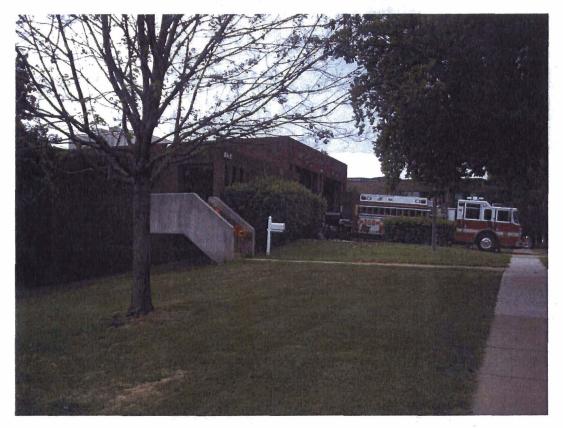
Fire Station 208

Built in 1976 the facility is located on Duke St and has very limited parking at the rear of the facility. The fire station construction is brick masonry construction. Roofing consists flat built–up roof membrane construction.
