Docket Item # 18
BAR CASE #2009-0128

BAR Meeting
July 8, 2009

ISSUE: Alterations
APPLICANT: ASCPT
LOCATION: 528 North Washington Street
ZONE: OC/Commercial Zone

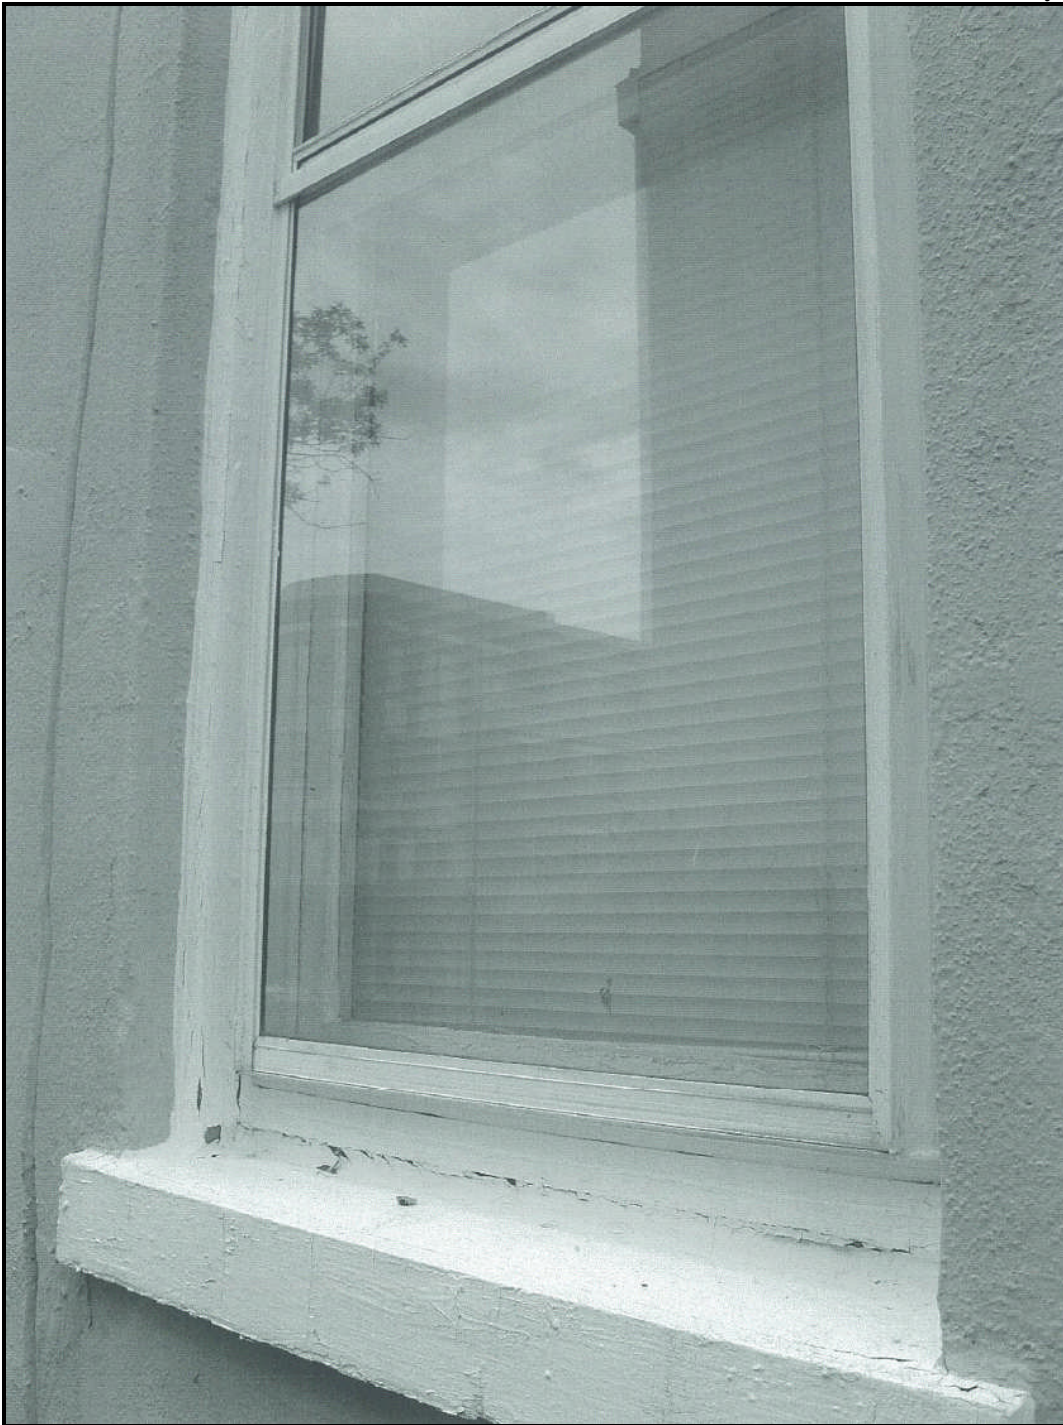
Prior to filing an application, the applicant contacted BAR Staff to inquire about window replacement. Staff conducted a site visit and determined that the existing windows were not in need of replacement and advised the applicant that the existing windows should be retained and repaired, perhaps with the installation of new storm windows. Staff advised that any window replacement would require approval by the Board but noted that Staff would be unable to support wholesale replacement. Staff notes that all of the historic windows on are in good condition and are in need of only standard repair and maintenance, including sash cord replacement and re-attachment to the

weights, repair of some broken glass, sanding and painting, weather stripping, and possible metal jamb liner installation if desired. These repair items are considered standard for historic, wood window maintenance and repair.

Figure 3. Window Survey: Existing Conditions-Exterior of Main Massing

In reviewing the application, Staff finds no convincing reason why the original windows cannot be retained and repaired. For energy efficiency, Staff recommends the applicant consider new wood, storm windows. There are many styles and materials of storm windows from which to choose, including storms that can be fitted on the interior of the window. Many studies have shown that a wood window in good condition fitted with a storm window can be as energy efficient as the more expensive replacement window. For the most energy efficient storm window option, due to the thermal exchange properties of wood, traditional wood-framed storm windows are recommended as they transfer less heat than metal-framed storms. Metal-framed exterior storm windows are currently installed on the building.

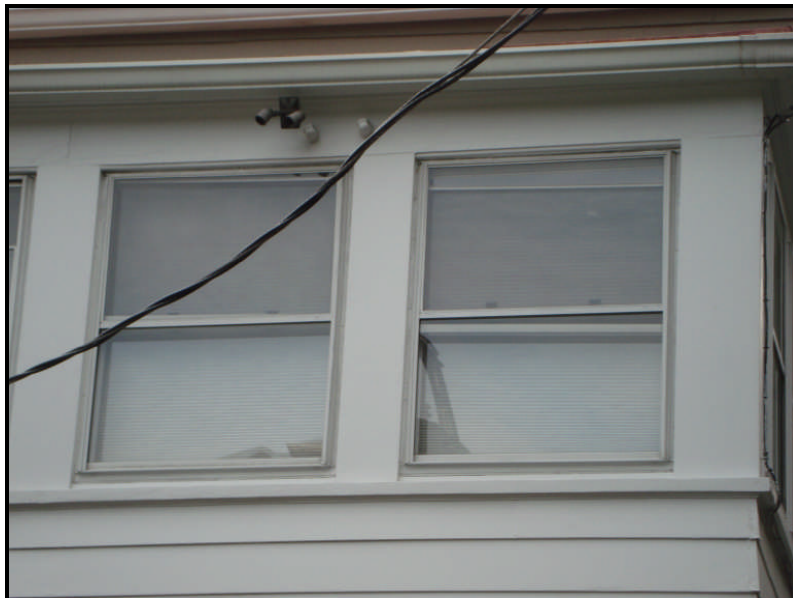
It has been determined that the rear frame addition's windows are not-historic (c1970), therefore Staff does not object to their replacement.

Figure 15. Rear Second-Story Addition's Windows

1. That the wood, windows on the main, brick and stucco massing will be retained and rehabilitated.
2. That the wood, windows on the rear frame, second story-addition, may be replaced with one-over-one wood double-glazed windows.
