Docket Item # 5
BAR CASE # 2008-0112

BAR Meeting
July 23, 2008

ISSUE: Alterations & Signage

LOCATION: 1000 Cameron Street

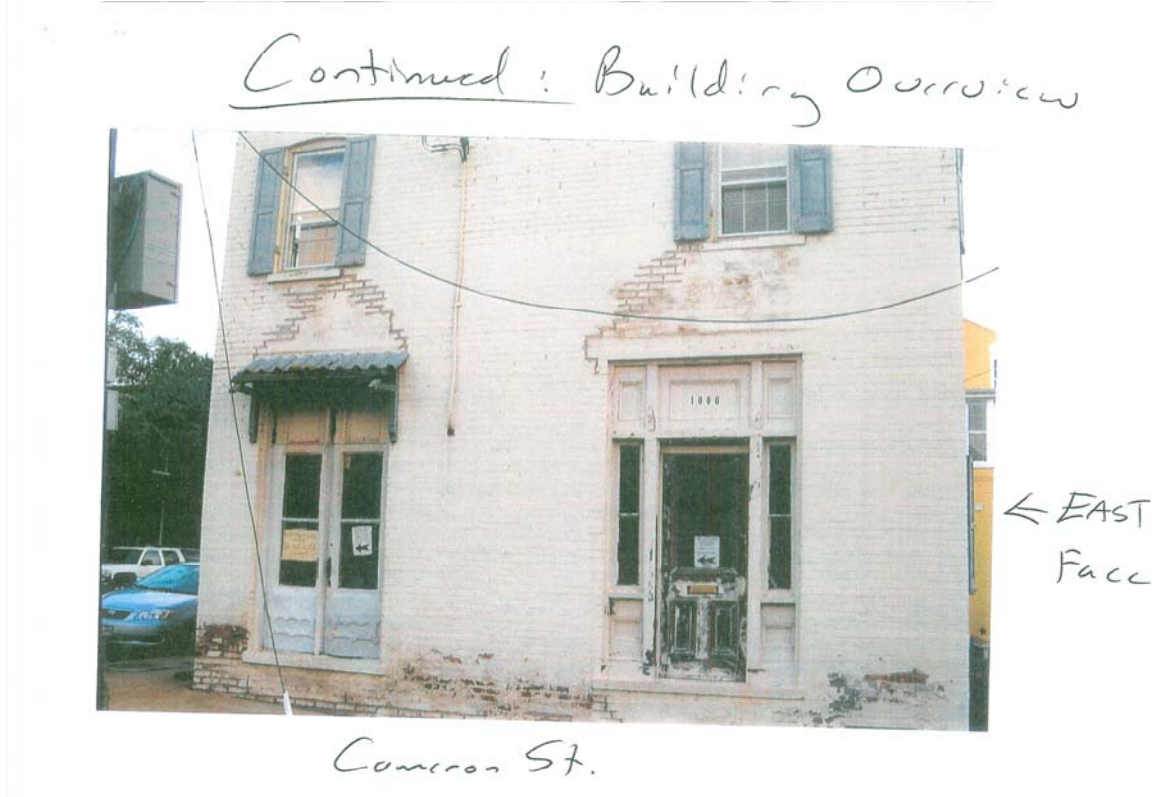
Figure 1: Cameron Street elevation

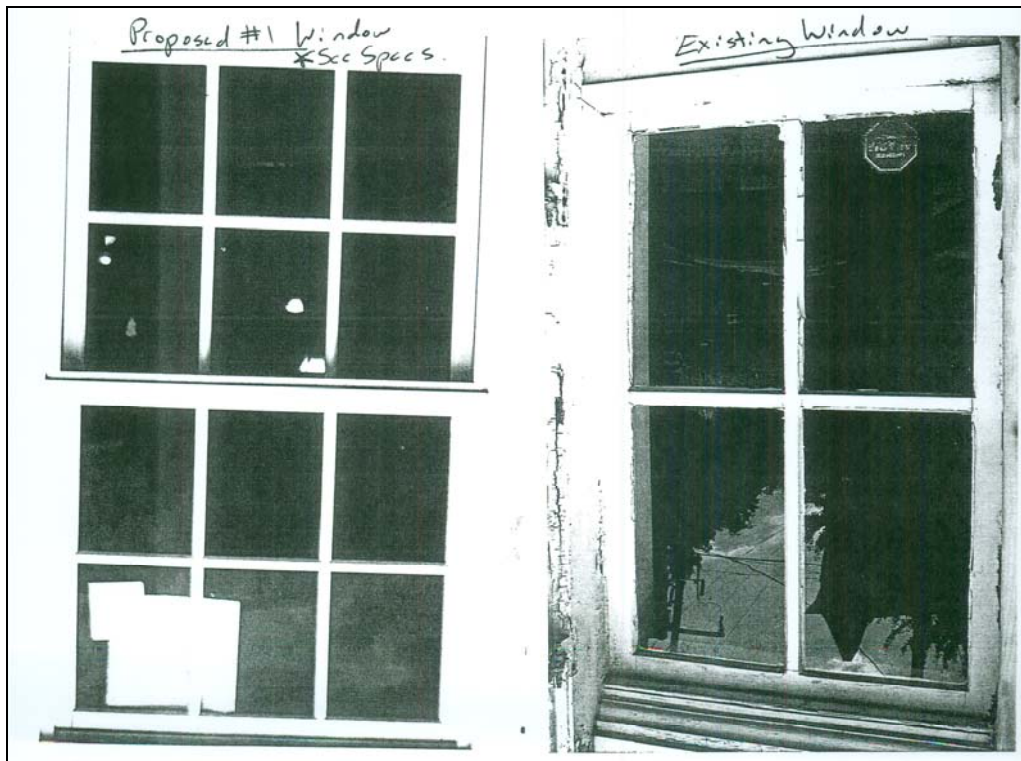
Figure 4: Existing and proposed windows

The applicant proposes to replace the existing wood windows with new wood windows. The existing windows on the first floor are fixed single sash windows with four lights. The upper windows are six-over-six, double-hung wood windows. The new windows are proposed to be Kolbe & Kolbe double-insulated, simulated divided light wood windows in a six-over-six configuration. The windows will be painted white.

The *Design Guidelines* recommend that all windows on historic properties be single glazed (1 pane of glass) with true divided lights, although the Board has on a number of occasions permitted the use of double pane insulated windows with exterior mullions and interior spacer bars, often in less visible locations. Double insulated windows, like those proposed by the applicant, have a different appearance than historic windows with single glazing. Because windows are such a character-defining feature of a building and this particularly building is highly visible, Staff recommends repair and retention of the historic windows on the first floor if feasible (Staff believes that these single sash windows may be original). Because the *Guidelines* state that “double glazed true divided light wood windows” are acceptable, Staff recommends approval of historically appropriate, two-over-two, true divided light, double insulated, wood windows with fixed exterior muntins and interior spacer bars for the second floor windows.

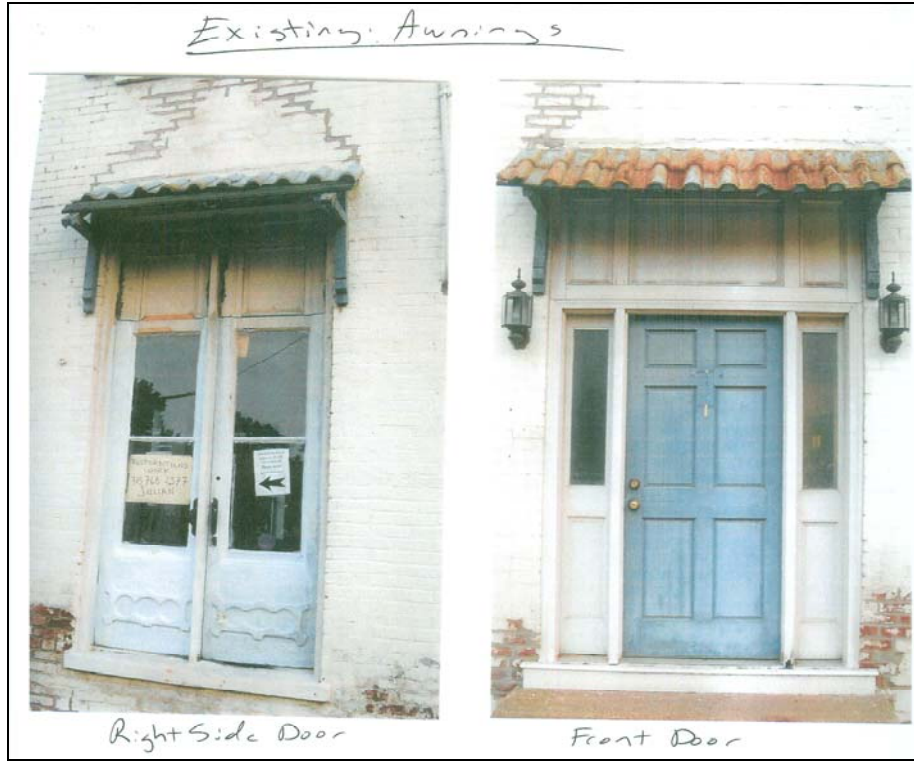
Figure 5: Existing awnings

The two existing Spanish tile door hoods, one facing North Patrick Street and the other fronting on Cameron Street, will be replaced with standing seam metal (either copper or tin) door hoods.

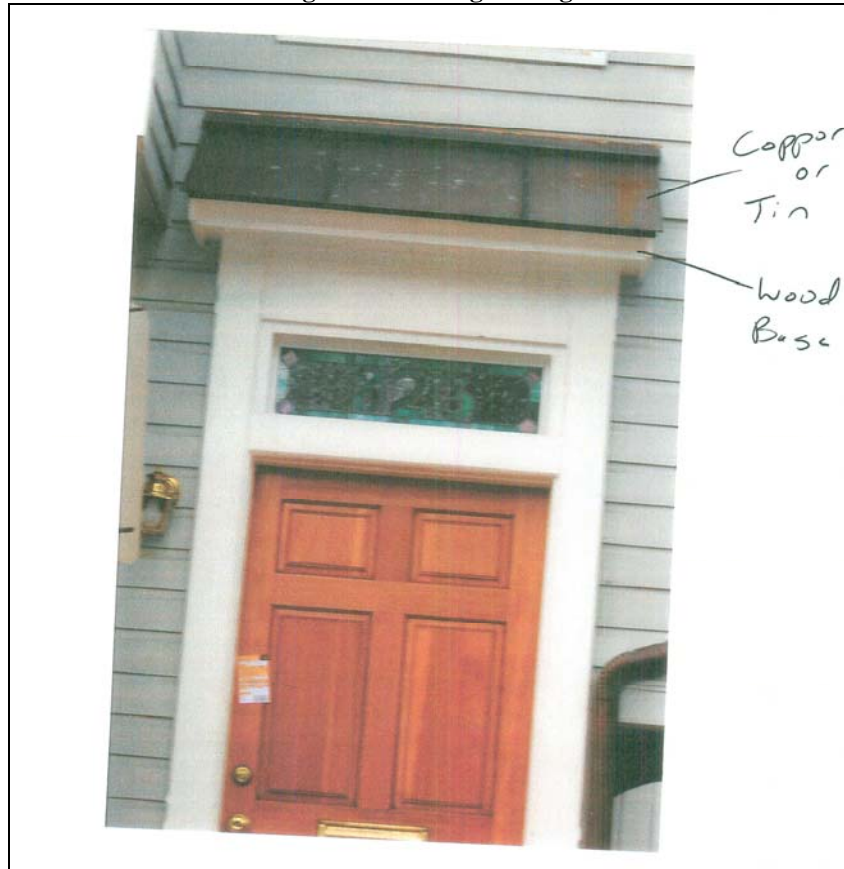
Figure 6: Proposed type of awning

Staff supports the replacement of the Spanish tile door hoods with construction of the standing seam metal door hoods provided that the existing brackets supporting the hood structures be either retained and repaired if possible or replaced-in-kind.

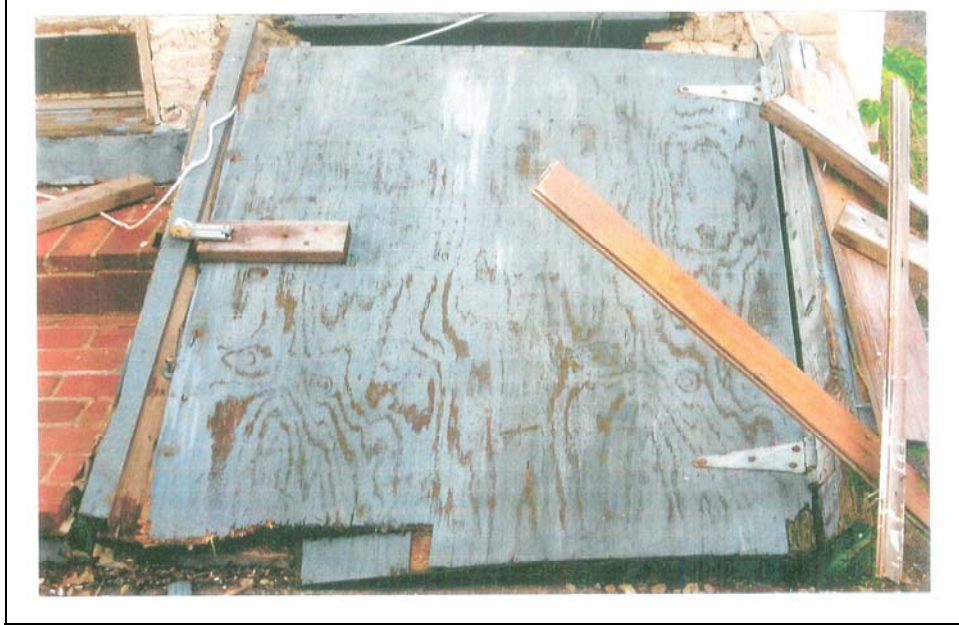
Figure 7: Existing basement hatch

The existing at-grade basement entrance on the west elevation is currently accessed by a hatch made from a single sheet of plywood. The existing door is in poor condition and the applicant proposes to replace it with new double hatch doors on a raised brick plinth. The hatch is proposed to be constructed of wood and will be painted black.

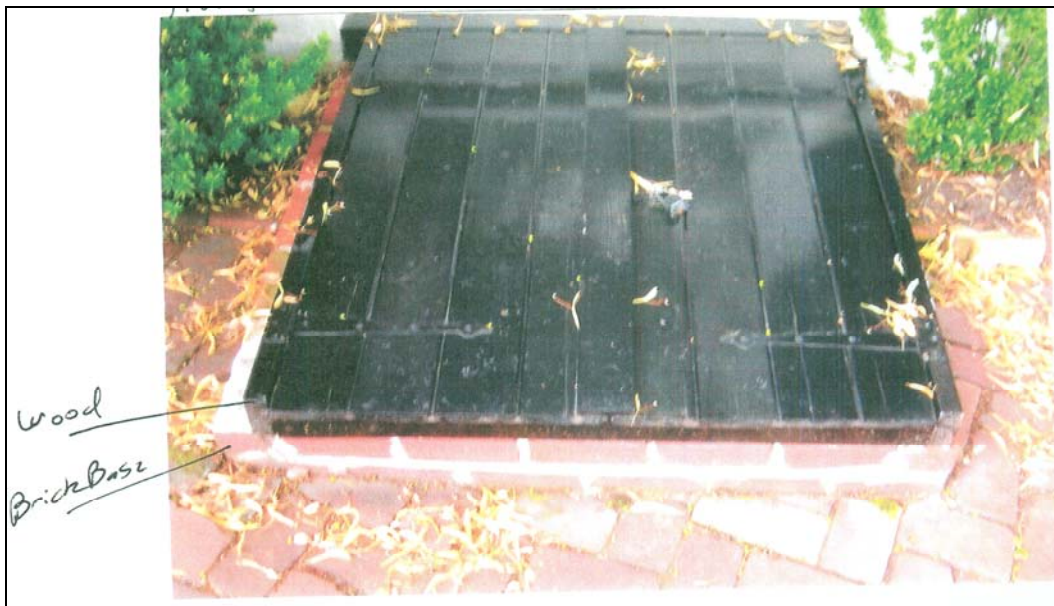
Figure 8: Proposed type of basement hatch

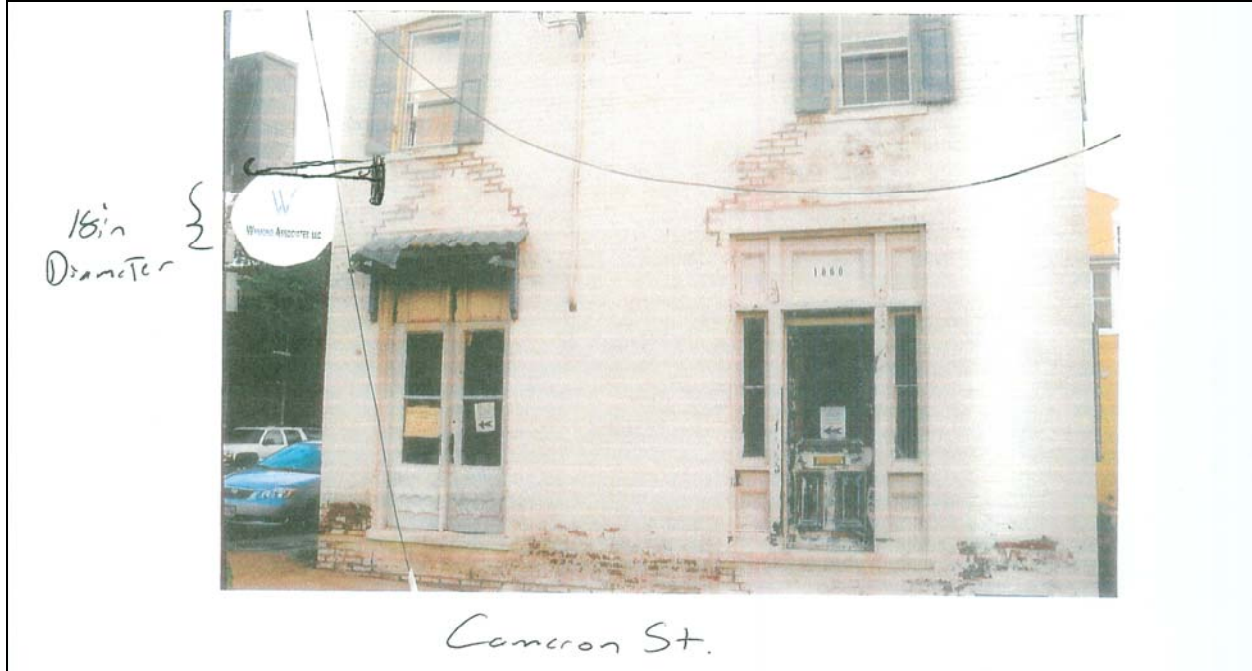
Figure 9: Proposed hanging sign

Although the *Design Guidelines* state that, “generally, only one sign per business is appropriate,” Staff believes that two signs are acceptable in this particular case because the building has two street frontages, as a corner building. However, Staff does object to the use of high density foam signs for this historic building and instead recommends that the applicant install either a wood or MDO (Medium Density Overlay plywood) signs. When applying for a sign permit the applicant should also include specifications for the metal bracket, which should be mounted into the mortar joints and not the historic brick.

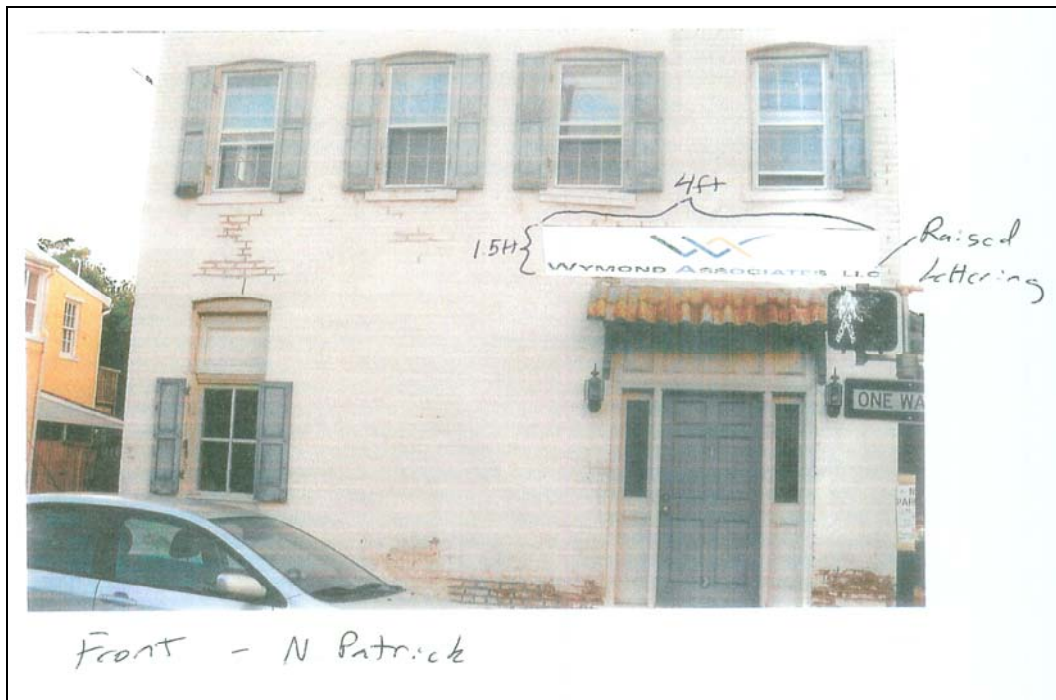
Figure 10: Proposed wall sign
