Docket Item # 6
BAR CASE #2006-0118

ISSUE: Addition and alterations
APPLICANT: Donald Walsh by John Savage
LOCATION: 323 Buchanan Street
ZONE: RB/Residential

The applicant is requesting a Certificate of Appropriateness for a one story rear addition and a number of alterations.

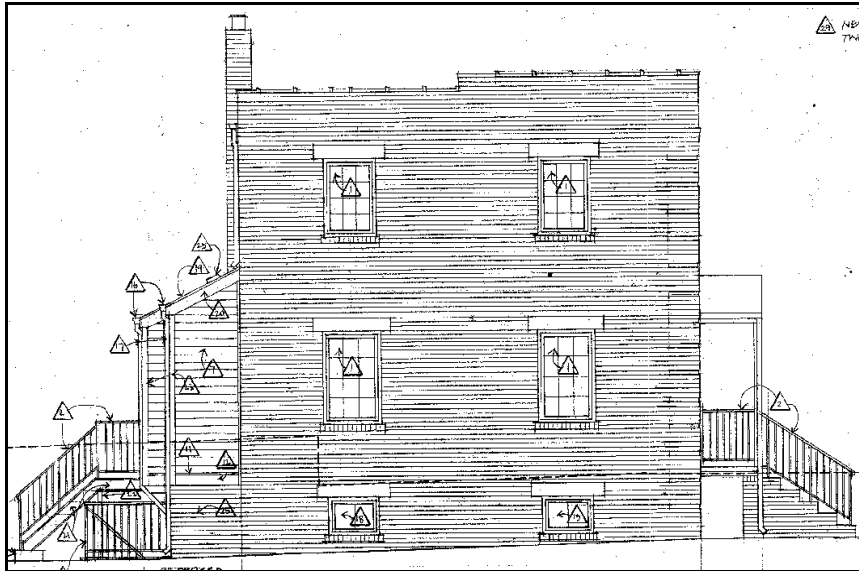
Figure 1 Proposed side elevation

Addition: The addition will extend the full width of the rear facade on the first story, replacing the existing rear stoop. Because the grade falls away on the property from front to back, the addition will be 4' above grade and will be supported on structural steel columns. The shed-roofed addition will be 3'9" deep by 14'6" wide with a stoop and door on the left side and a shallow projecting bay on the right side. The addition will be clad in fiber cement lap siding with asphalt shingle roofing. The trim, including corner boards, band board at the base and door surround will be of fiber cement. The existing rear two panel metal door with nine lights will be reused at the rear of the new addition with a new simple aluminum storm door. It will be accessed by a set of steel steps with simple steel railings with straight pickets and a lamb's tongue return. The railings, stoop and steps and will be painted black. The rear entrance will be lit by a cannister type light fixture. The bay will project 1'6" beyond the rear (northeast) facade of the addition and will have a pair of multi-light, aluminum-clad casement windows. A pre-finished aluminum gutter will extend across the rear elevation at the eave. There will be a pre-finished aluminum downspout at the right corner.
