City of Alexandria, Virginia

MEMORANDUM

SUBJECT: CONSIDERATION OF INSTALLATION OF A TRAFFIC SIGNAL AT THE INTERSECTION OF FRANKLIN STREET AND COLUMBUS STREET

TRAFFIC AND PARKING BOARD PUBLIC HEARING JANUARY 28, 2008

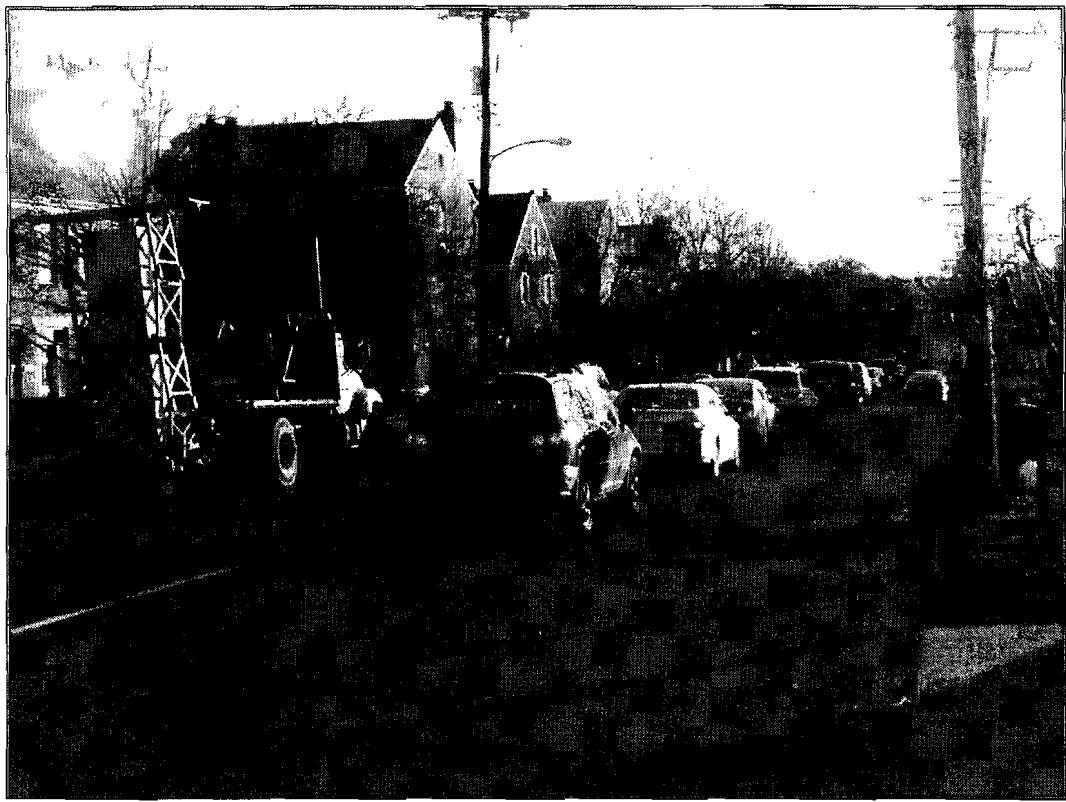
Photograph C. AM peak period - Spillover from upstream intersection. Signal at Washington Street and Franklin Street is in the background.

Occasionally spillback was recorded in the right and center travel lanes of Franklin Street due to queuing at the downstream signal of South Washington Street & Franklin Street during AM peak hours. On most occasions, the spillback sustained for a couple of cycle lengths.
