Docket Item # 4  
BAR CASE # 2010-0217

BAR Meeting  
September 1, 2010

**ISSUE:** Alterations  
**APPLICANT:** Soonja Purdy  
**LOCATION:** 600 South Washington Street  
**ZONE:** CL / Commercial

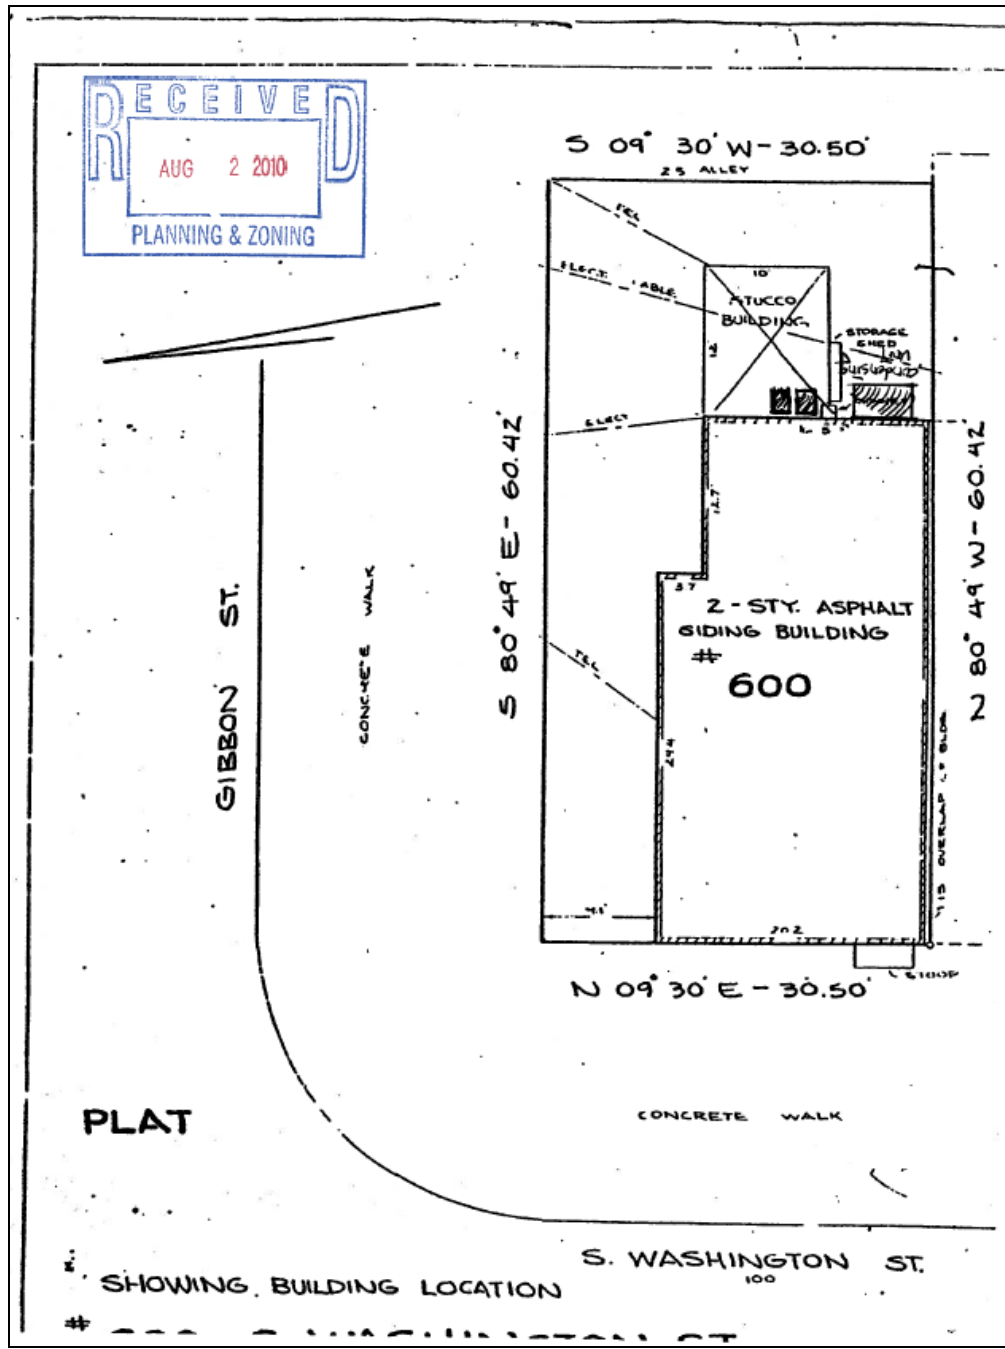
Figure 1. Plat showing location of propose units.

The applicant is requesting approval of a Certificate of Appropriateness for screening two new HVAC condenser units at the rear of 600 South Washington Street. This property is located at the corner of South Washington and Gibbon streets. The rear of the property is highly visible. The proposed screening is a closed picket wood fence measuring six feet in height.

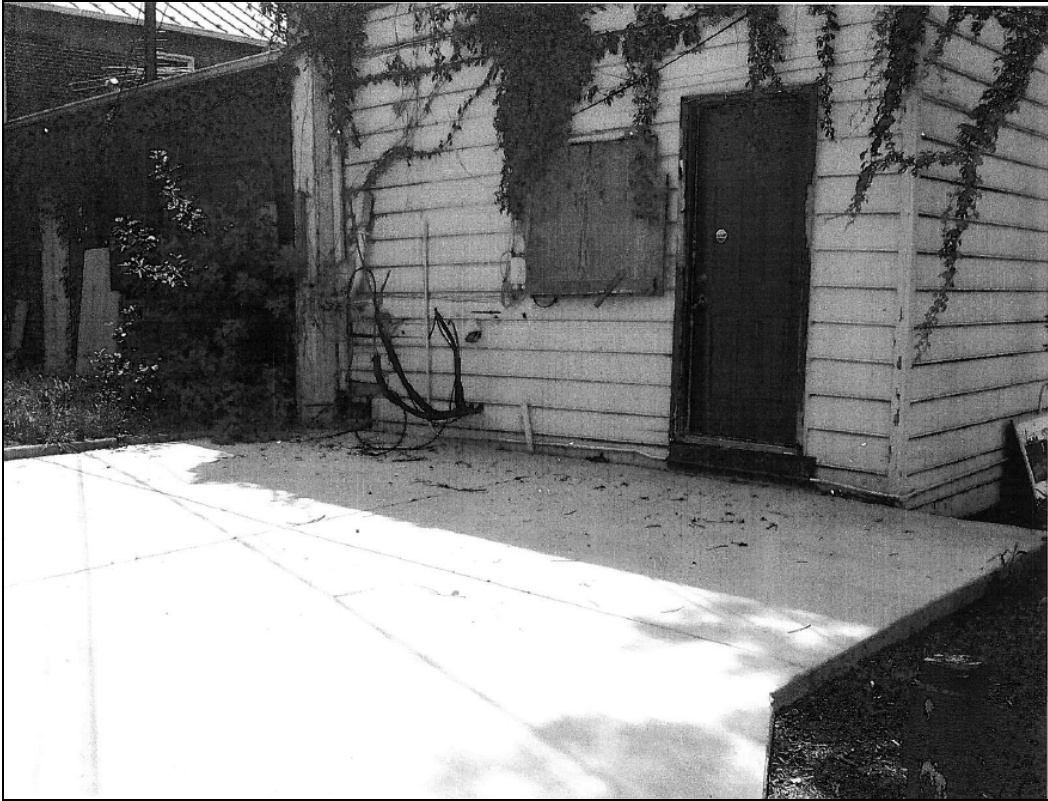
Figure 3. Existing conditions at rear elevation.

The proposed screening would be more appropriate if it screened the rear area with the concrete pad, garbage cans and the like. Staff recommends locating the fence in line with the rear ell and extending it to the rear property line. The applicant can fully enclose this rear portion if desired. As this application suggests that central AC has been installed, Staff recommends that the existing through-the-wall unit be removed and that the void be patched with siding to match the existing.

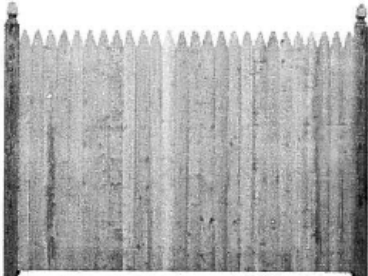
Pre-assembled wood fence panels install easily. Panels are made with 2x3 backer rails.

- Pre-assembled
- Adds beauty and privacy to home or garden
- Easy to install
- Galvanized Nails
  - **Contact Type Allowed** : Above Ground
  - **Energy Star Compliant** : No
  - **Fastener Type For Use With ACQ** : ACQ Double Hot Dipped Galvanized or Stainless Steel
  - **Length** : 8 ft
  - **Nominal Size (In Fractions)** : 6x8
  - **Paint Type Recommended** : Oil Based & Latex
  - **Panel Height (in.)** : 72 in
  - **Panel Thickness** : 2 in
  - **Panel Width (in.)** : 96 in
  - **Pressure Treated** : Yes
  - **Recommended Primer Type** : Latex
  - **Type of Pressure Treatment** : CA - Copper Azole
  - **Width** : 6 ft

Figure 4. Specifications for proposed fence/screening.
